OPERATION REPORT
FEDERAL ENERGY REGULATORY COMMISSION
OFFICE OF ENERGY PROJECTS
DIVISION OF DAM SAFETY AND INSPECTIONS
CHICAGO REGIONAL OFFICE

For the period October 23, 2003 to September 30, 2004

Licensee Ameren UE Project No. 2277

Project Name Taum Sauk NATDAM Nos. MO30040 and MO30041

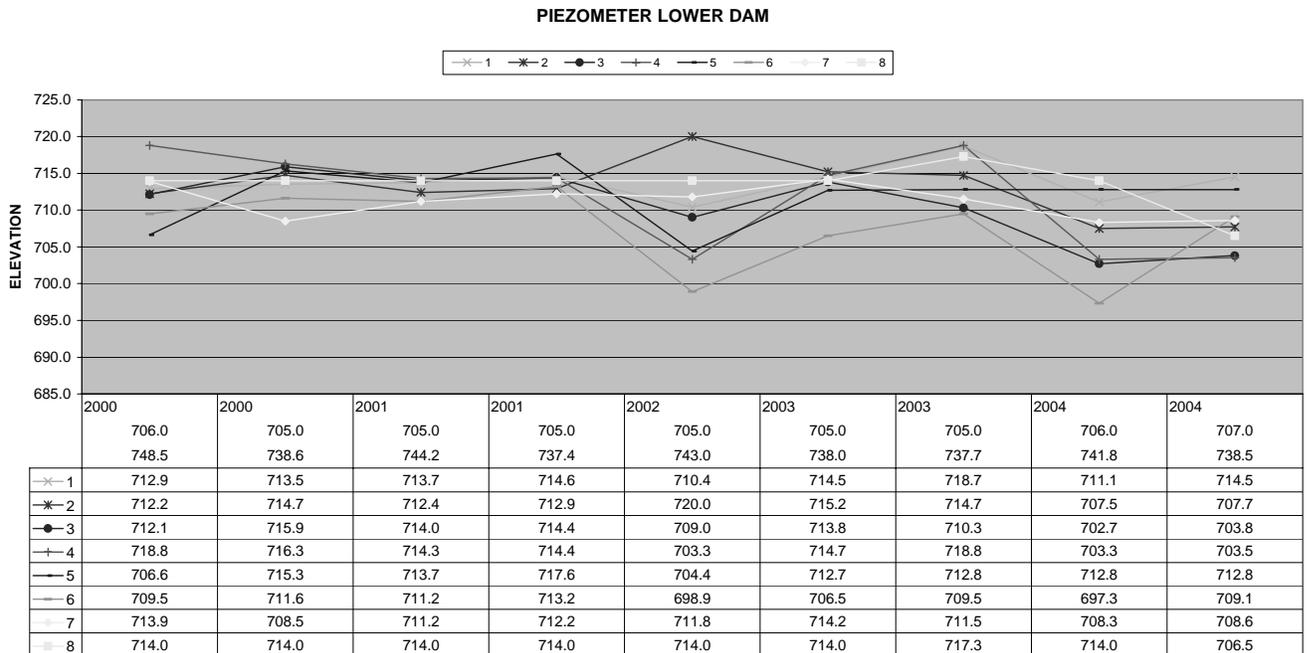
The licensee also maintains eight piezometers in the gallery of the lower dam and monitors them twice a year. We reviewed piezometer readings for the past several years during this inspection, and found uplift pressures to fall within normal ranges (see graph below).

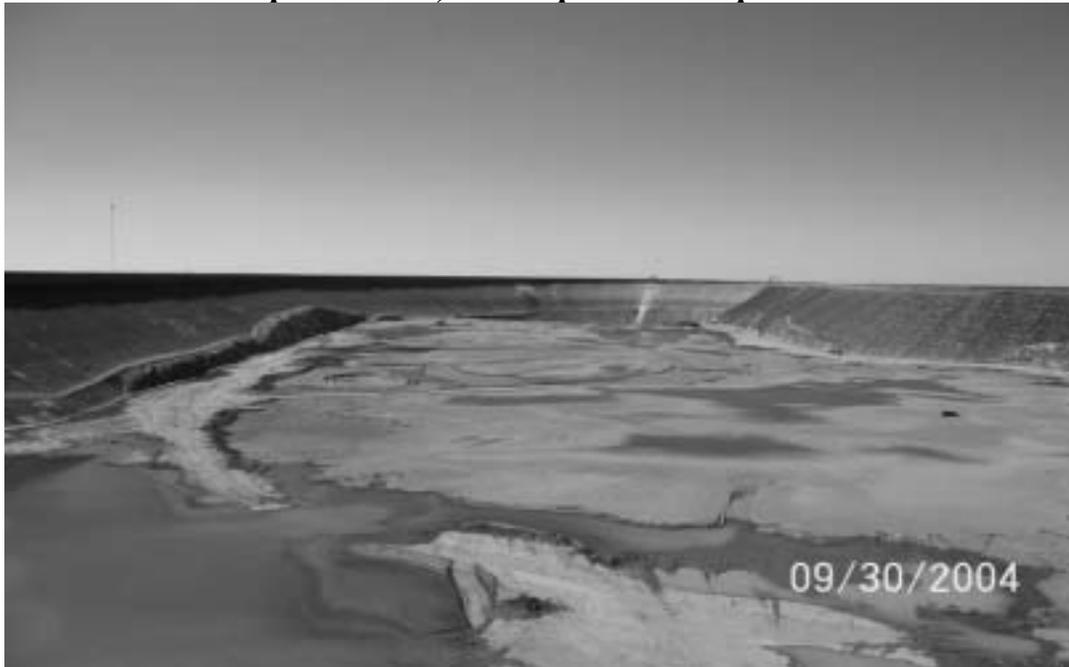
At the time of the inspection, the upper dam was undergoing maintenance work (Photographs 1 through 4. Note the morning glory intake shown in photographs 5 and 6). Specifically, the upstream face of the upper dam was being lined with geomembrane. The purpose of this work is to minimize the leakage through the rockfill dam. To conduct this work the licensee emptied the reservoir. Therefore, no leakage was noted at the time of this inspection. The underlying riprap appears stable and in good condition. No unusual settlement or displacements were noted in the crest or parapet wall (Photographs 7 through 10). Pattern cracking is present in the parapet wall, as noted in our previous inspections. The cracking has not changed appreciably since our previous inspection (Photograph 9).

Photograph 1 - The upper reservoir - empty at the time of the inspection.

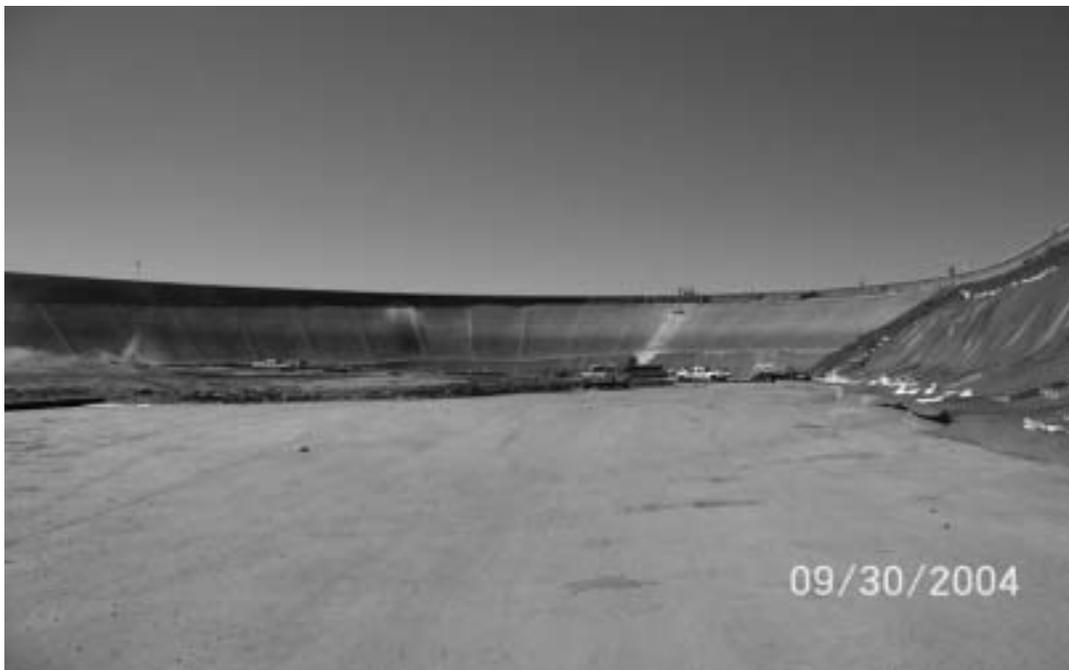
Photograph 2 - Same as the above, different location.

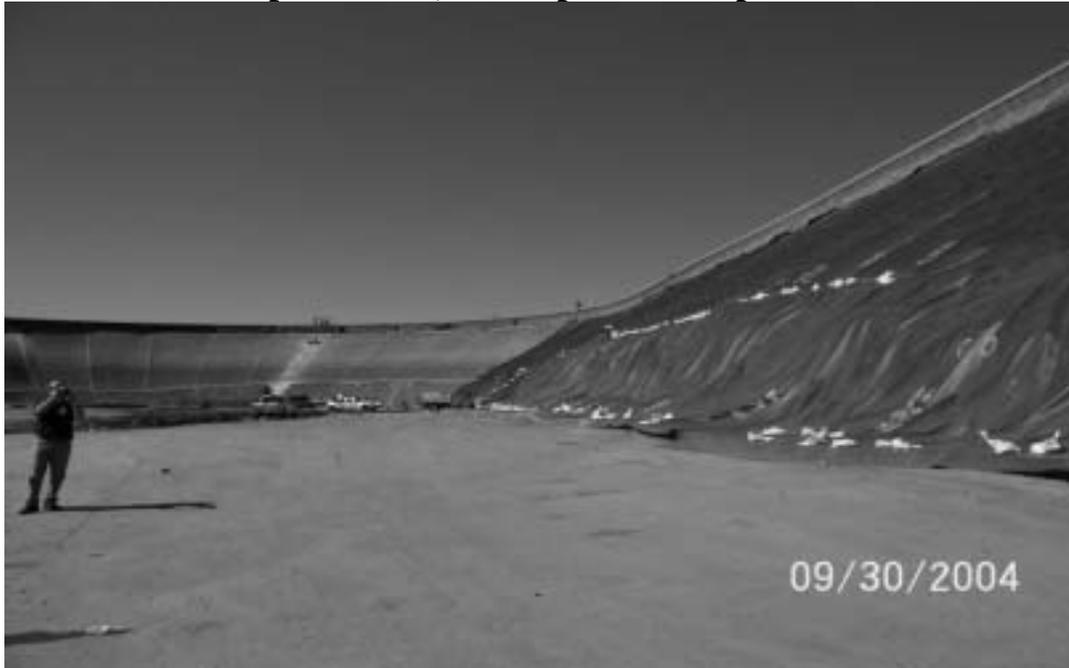
Photograph 3 - New lining being placed.

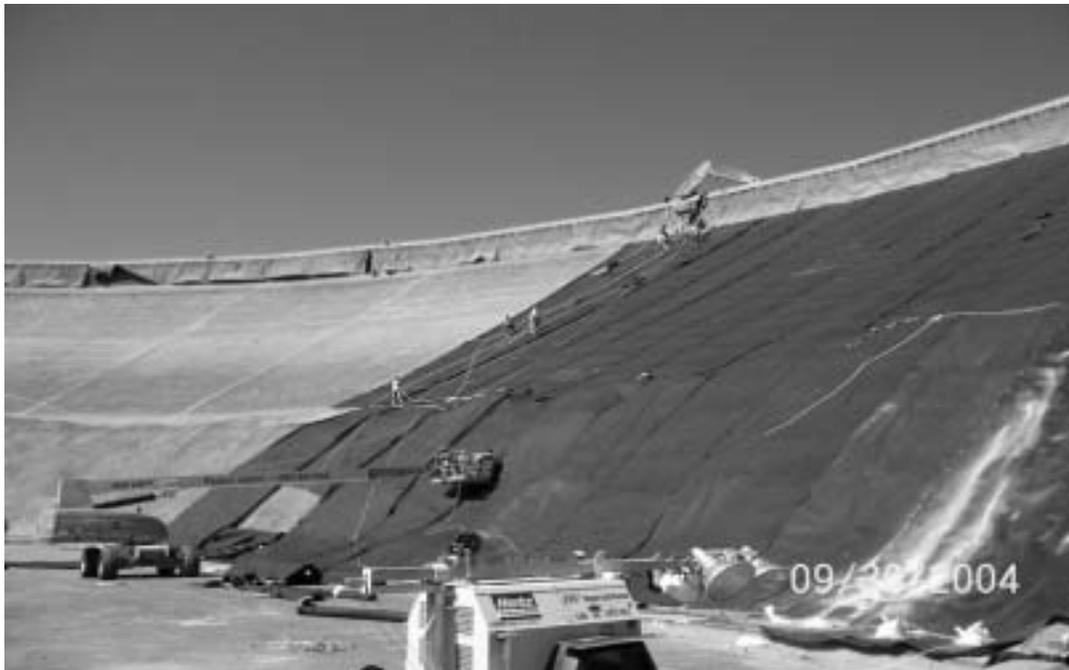
Photograph 4 - Same as the above.

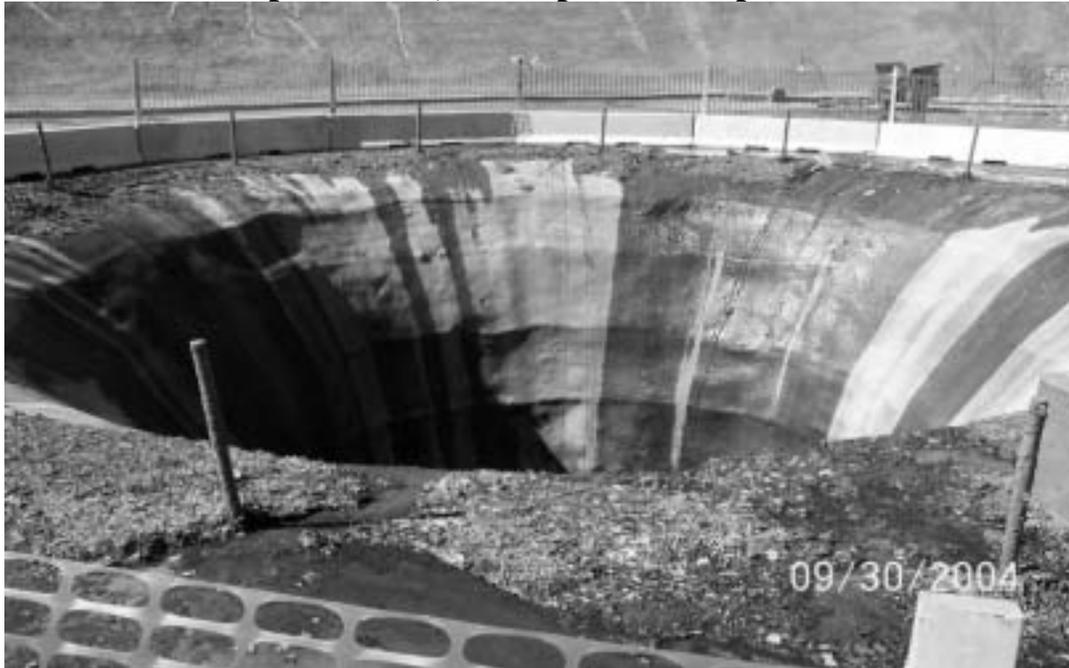
Photograph 5 - The powerhouse intake.

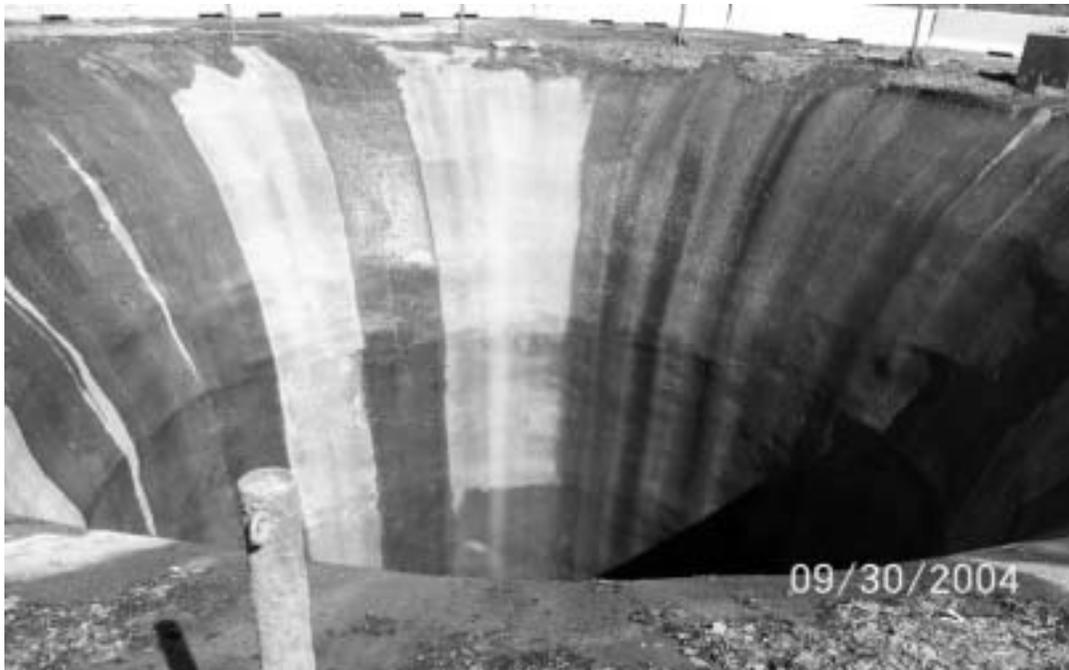
Photograph 6 - Same as the above, different location.

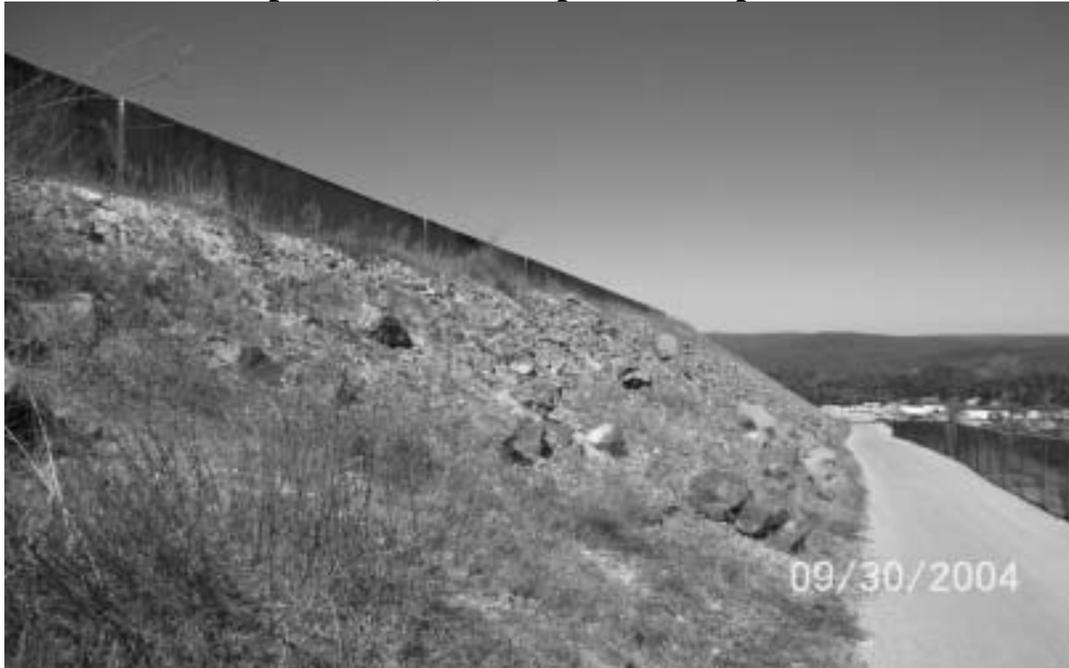
Photograph 7 - The rockfill upper dam.

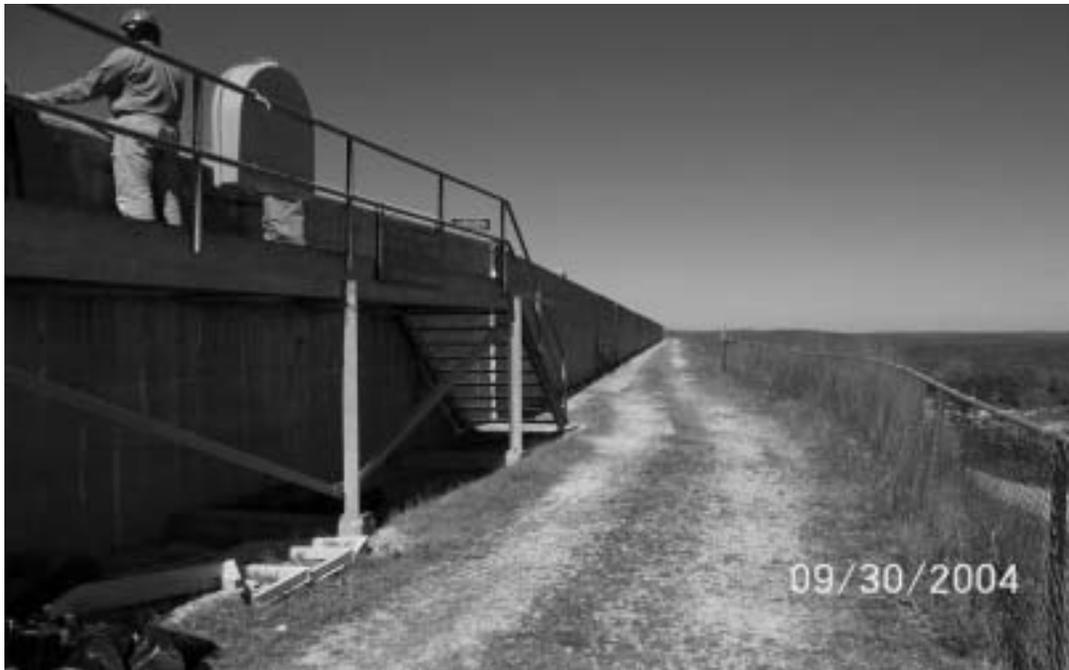
Photograph 8 - The 10-foot parapet wall that crowns the embankment.

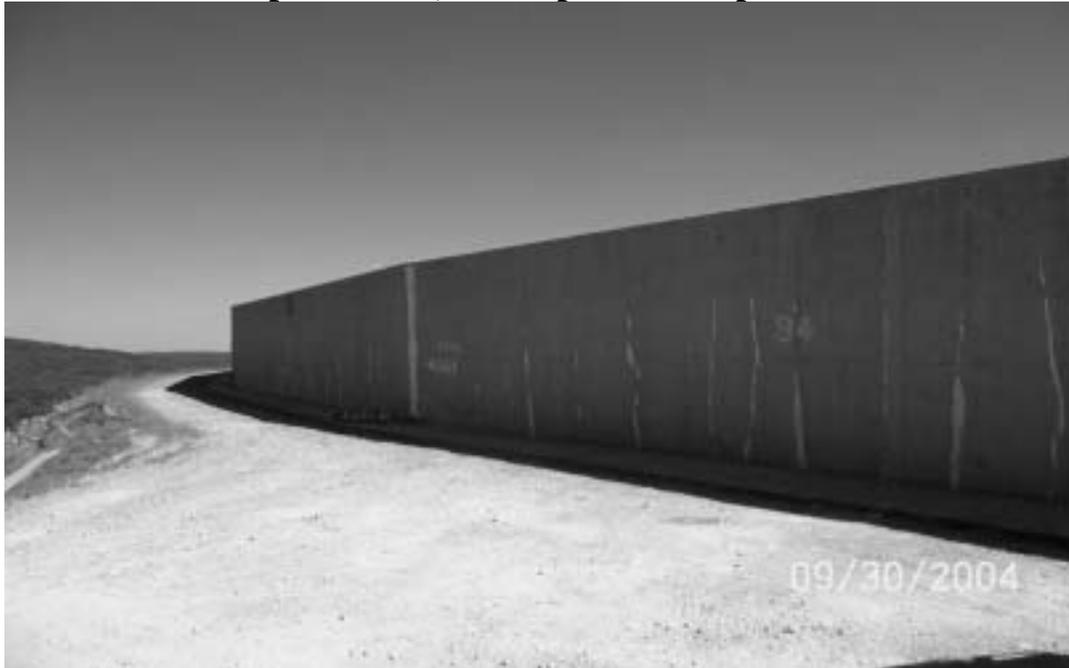
Photograph 9 - Same as the above. Note the cracks.

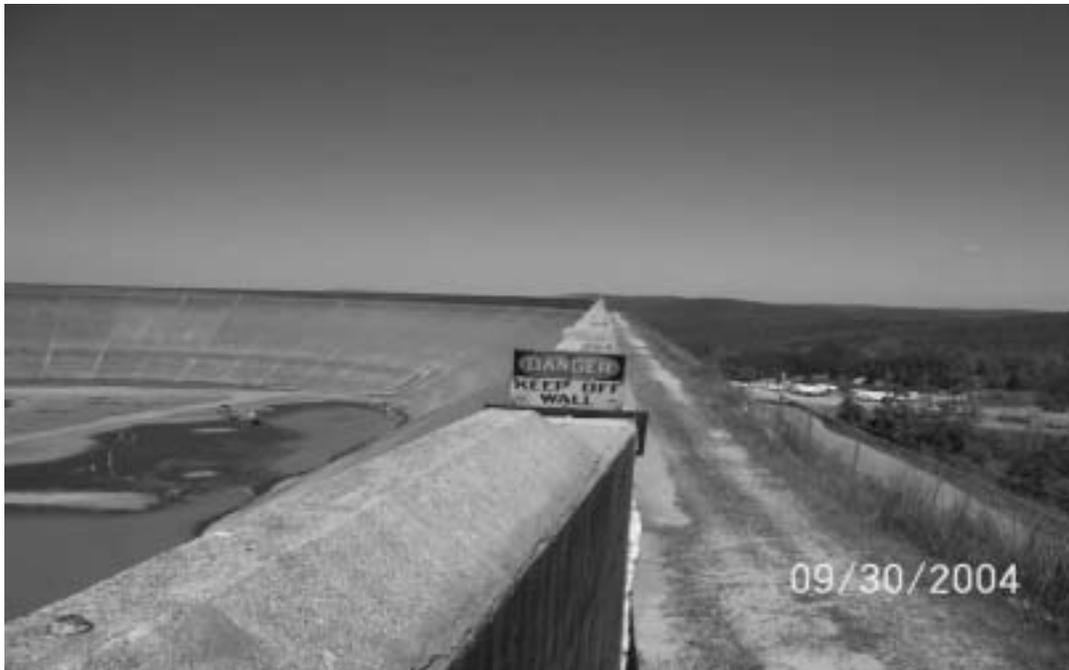
Photograph 10 - No significant unreported defects were noted in the parapet wall.

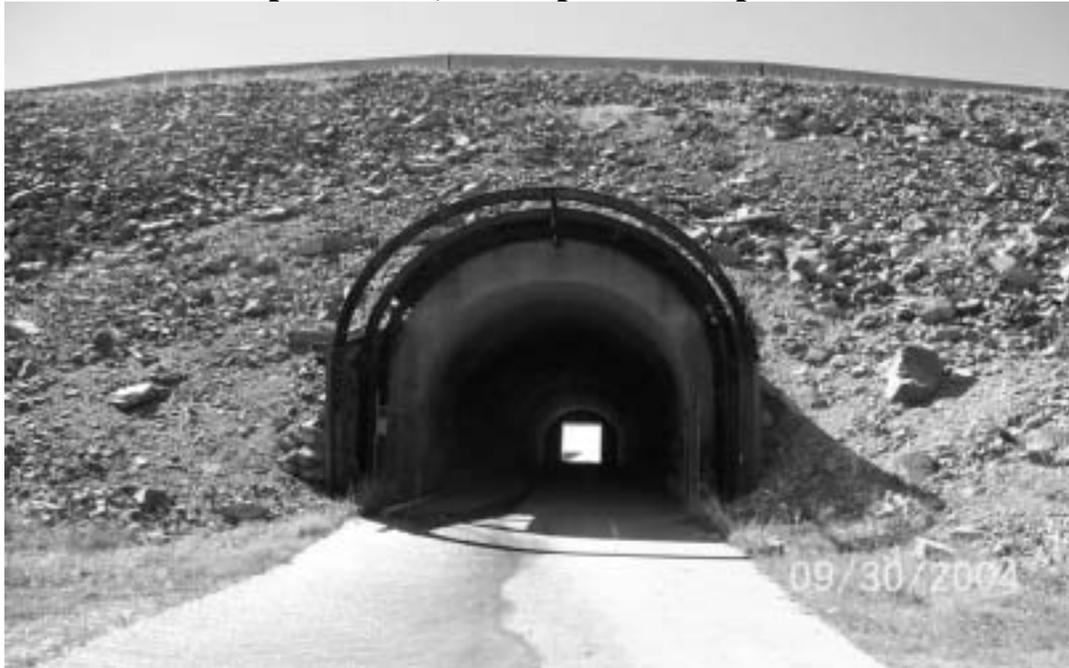
A concrete lined access tunnel is located on the northeast side of the Upper Dam, which allows access to the floor of the reservoir when it is dewatered. The access tunnel was inspected and found to be in good condition (Photographs 11 and 12). Except for the crack in the crown of the tunnel, no significant cracks or leakage were noted in the lining.

Photograph 11 - The concrete lined access tunnel to the floor of the upper reservoir open to traffic due to construction.

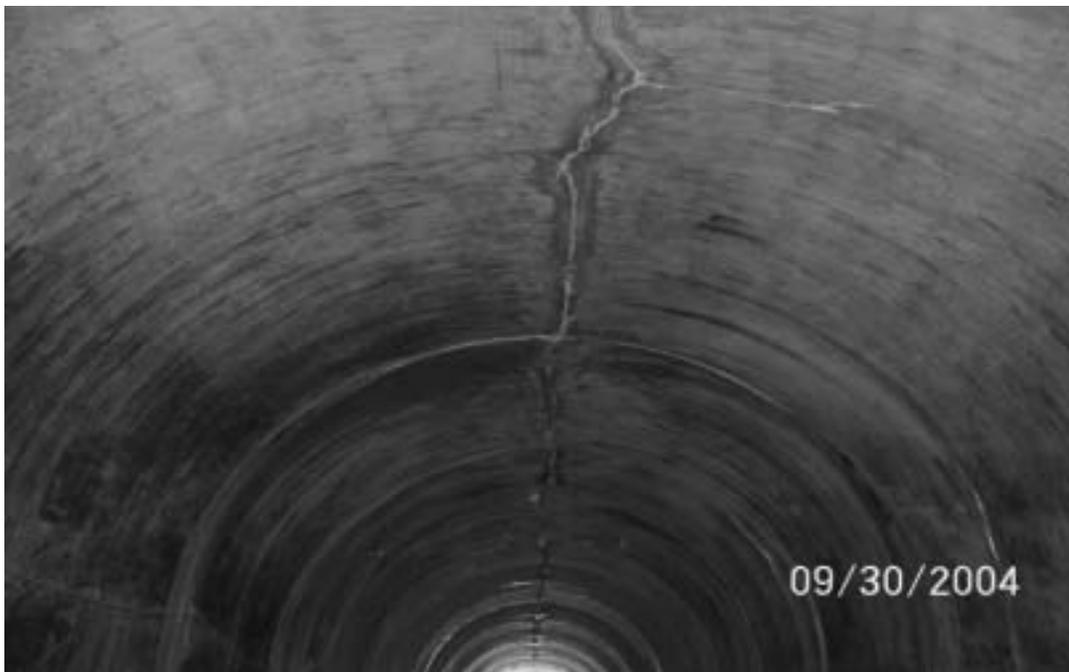
Photograph 12 - Crack along the apex of the tunnel. No change from previous inspections.

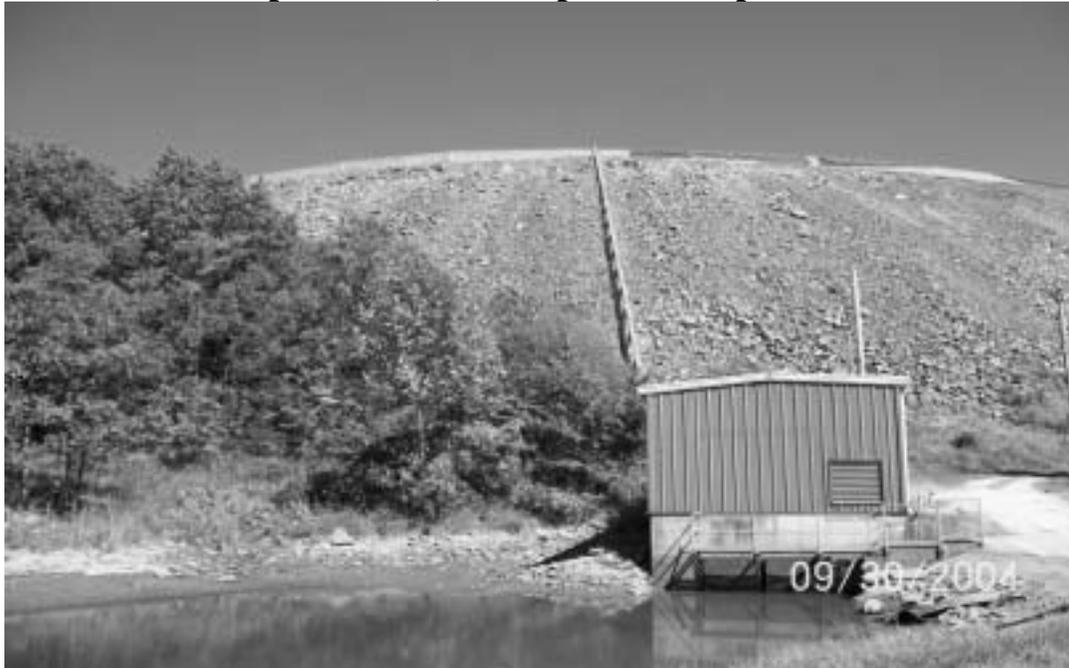
Collection Pond Dike- Drainage ditches surrounding the toe of the dike direct all leakage into a collection pond (Photograph 13). A small dike retains water in the collection pond, where it is pumped back into the upper reservoir. When the leakage rate

Photograph 13 - Seepage collection pond.

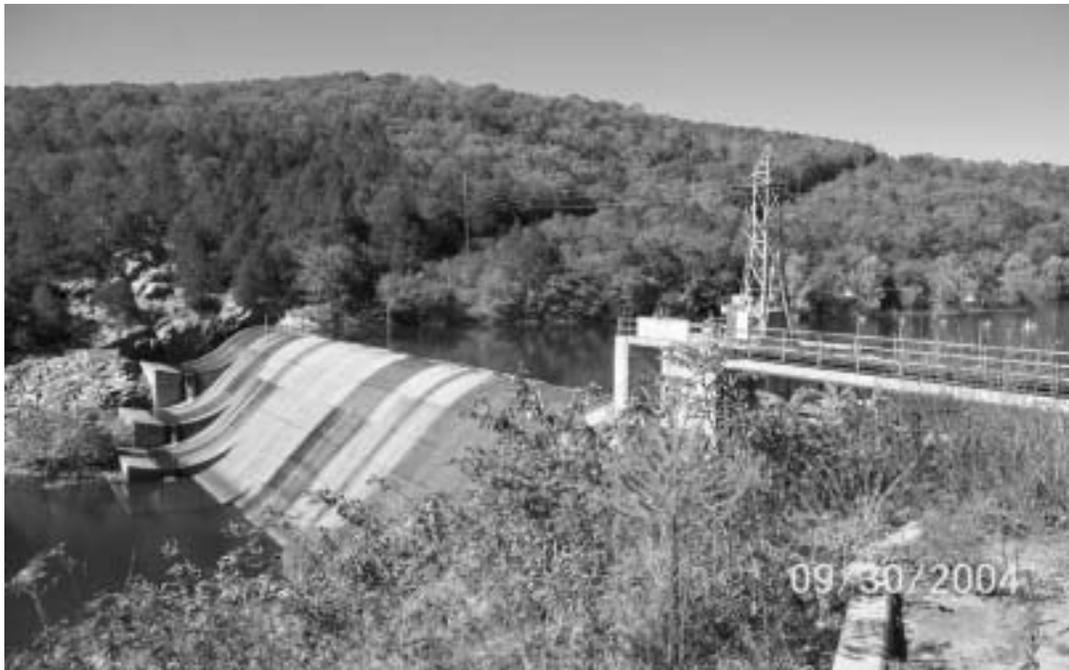
Photograph 14 - The lower concrete dam.

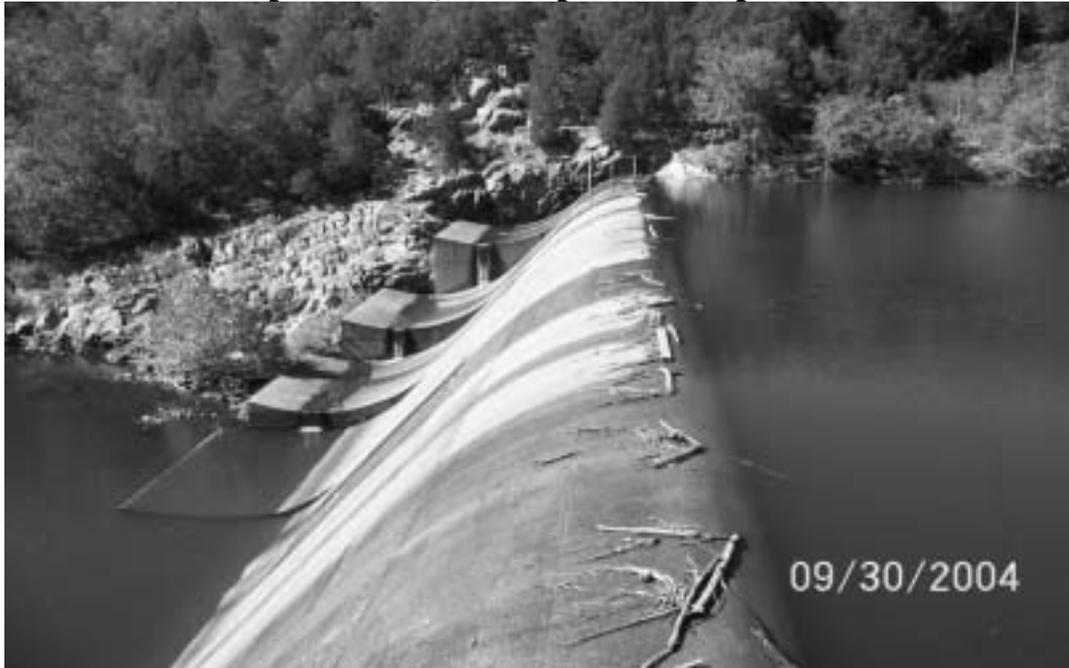
Photograph 15 - The crest of the ogee crest.

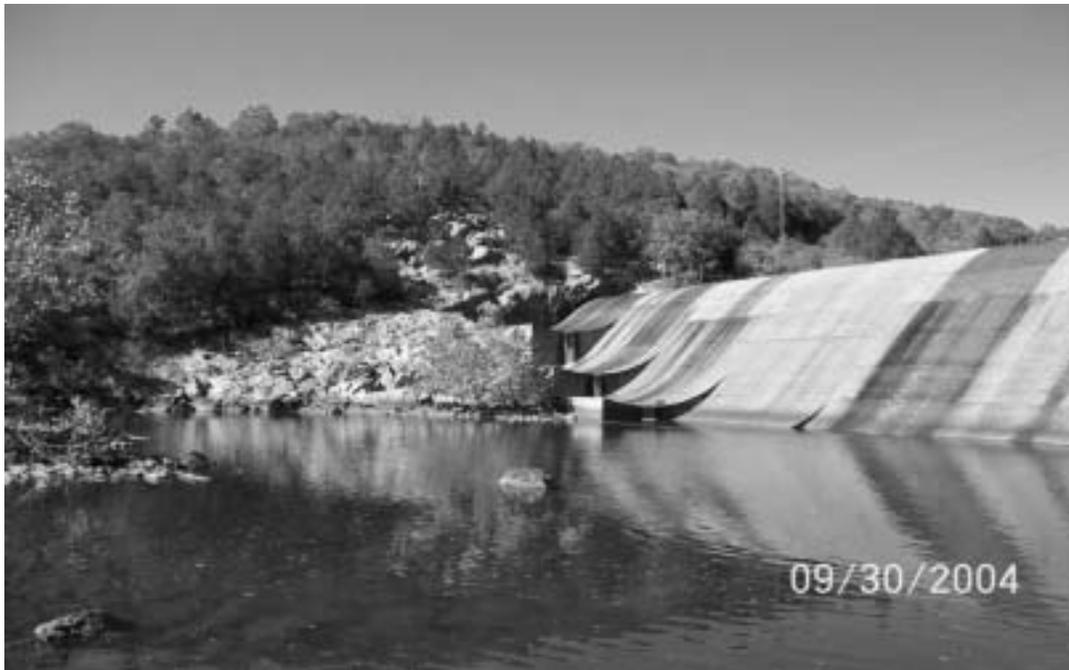
Concrete Dam- The lower reservoir gravity dam is about 60 feet high and 390 feet long founded on rock with rock abutments at each end (Photographs 14 - 17). Both abutments were in good condition at the time of our inspection with no signs of instability or excessive seepage (Photographs 16, 17, and 19). The concrete appeared to be in good condition with no evidence of significant cracking, spalling, deterioration, or displacements. Minor leakage was noted along horizontal joints in the monoliths but the discharge was very small (Photographs 16 and 17).

Photograph 16 - The downstream face of the concrete dam.

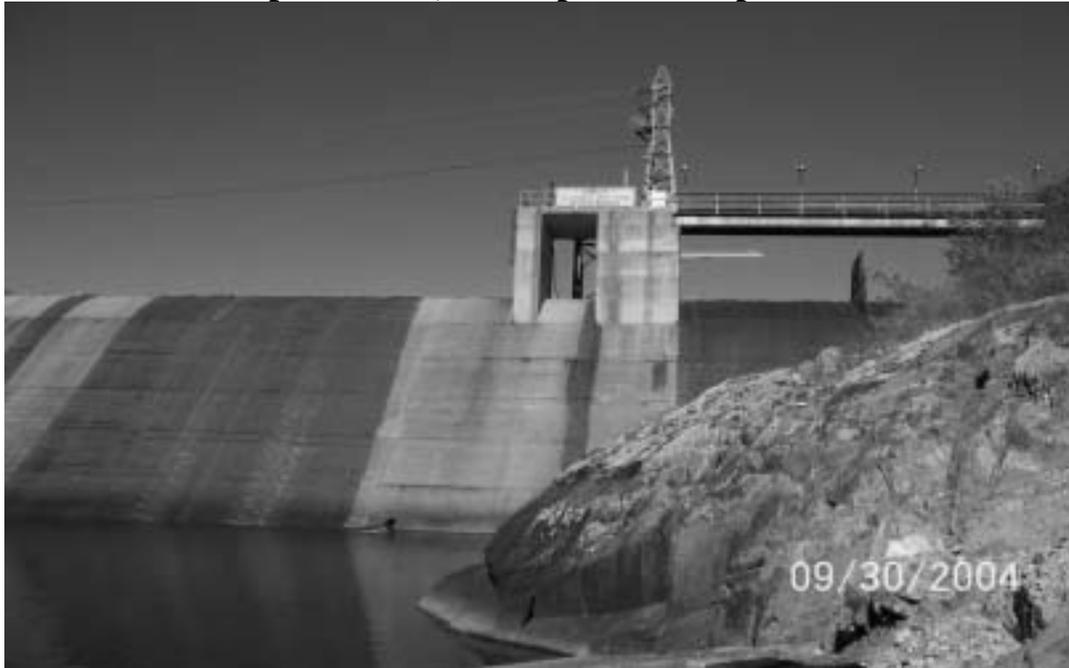
Photograph 17 - Same as the above.

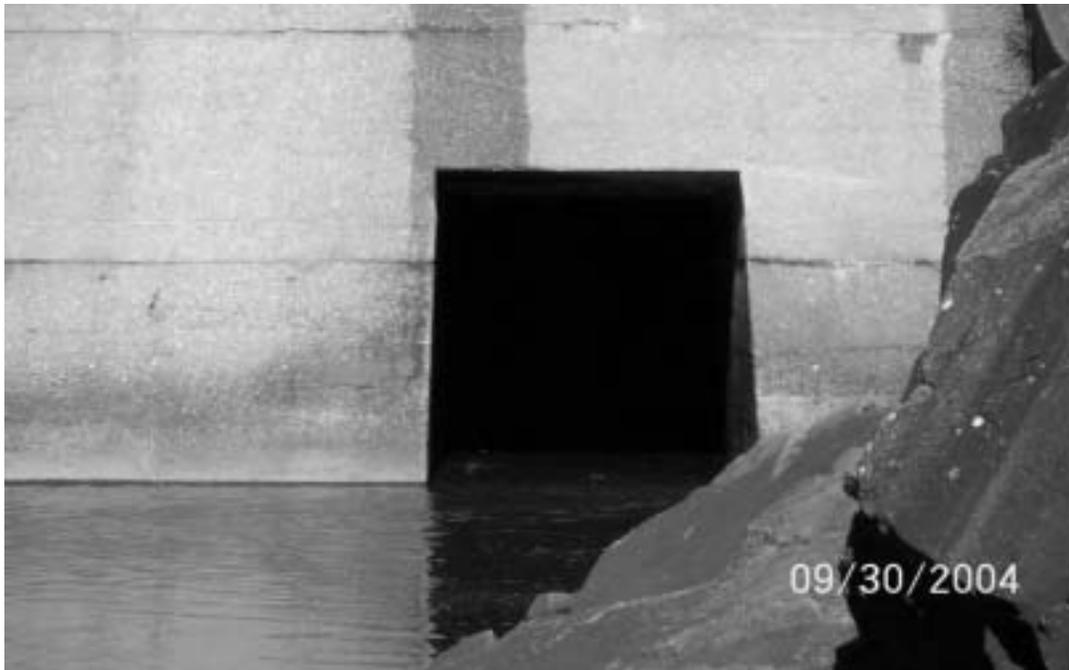
The minimum flow gate was open 3% at the time of our inspection with a flow of approximately 0.75 cfs. No other flow was occurring over the dam. The plunge pool below the toe of the dam appeared to be in good condition (Photograph 18).

Photograph 18 - Sluiceway outlet at the left side of the dam.

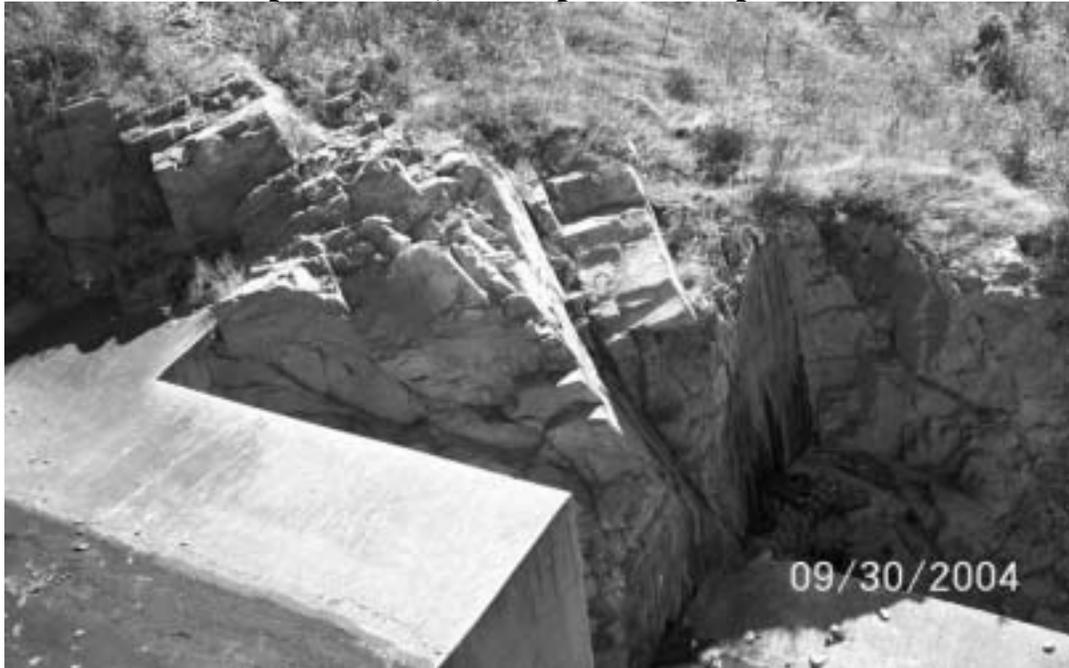
Photograph 19 - The left abutment of the concrete dam.

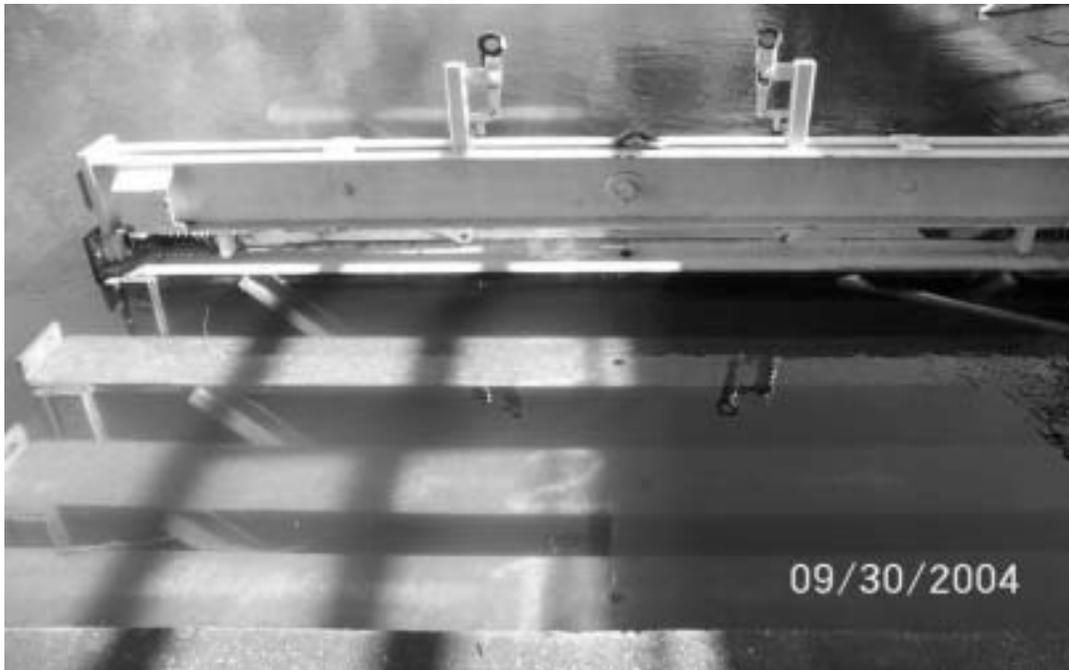
Minor modifications were made to the dam recently. A steel deck, stoplog rack, and lifting beam were added for storage and placement of stoplogs at the sluice gate bay (Photograph 20). This work was completed during the summer of 2003 and was not coordinated with the FERC. Upon review following our 2003 inspection, we found that the new deck would have no significant impact to the spillway capacity or stability of the dam, and therefore no further coordination with the FERC is recommended. In addition to these modifications, the licensee replaced the cables on the boat barrier with stainless steel cables.

Photograph 20 - Gates for the lower sluiceway.

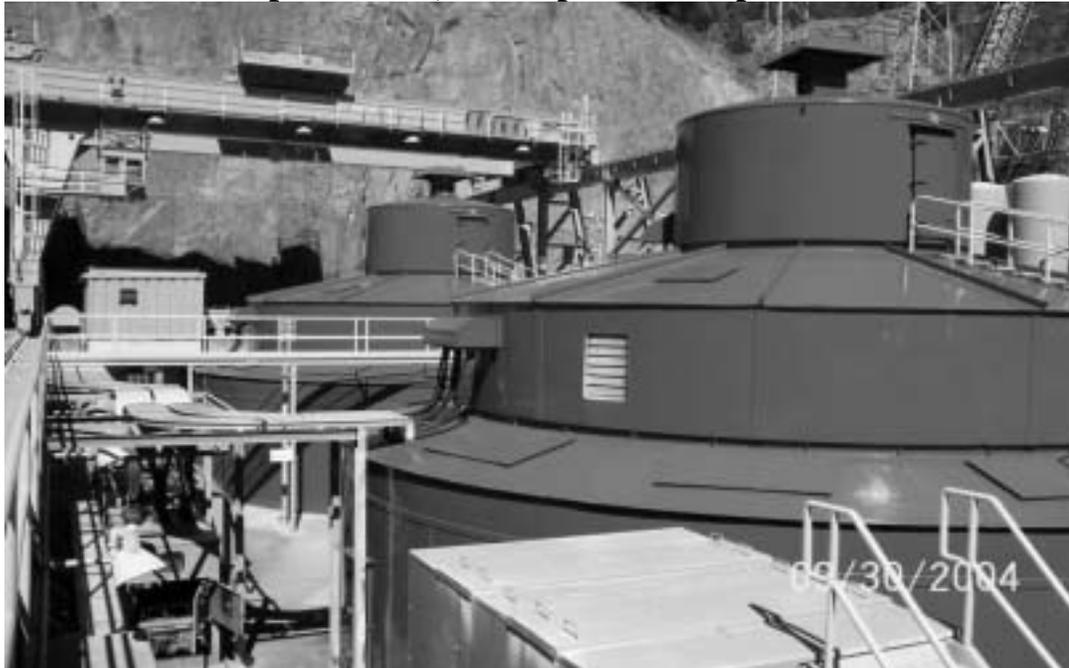
Photograph 21 - The powerhouse area.

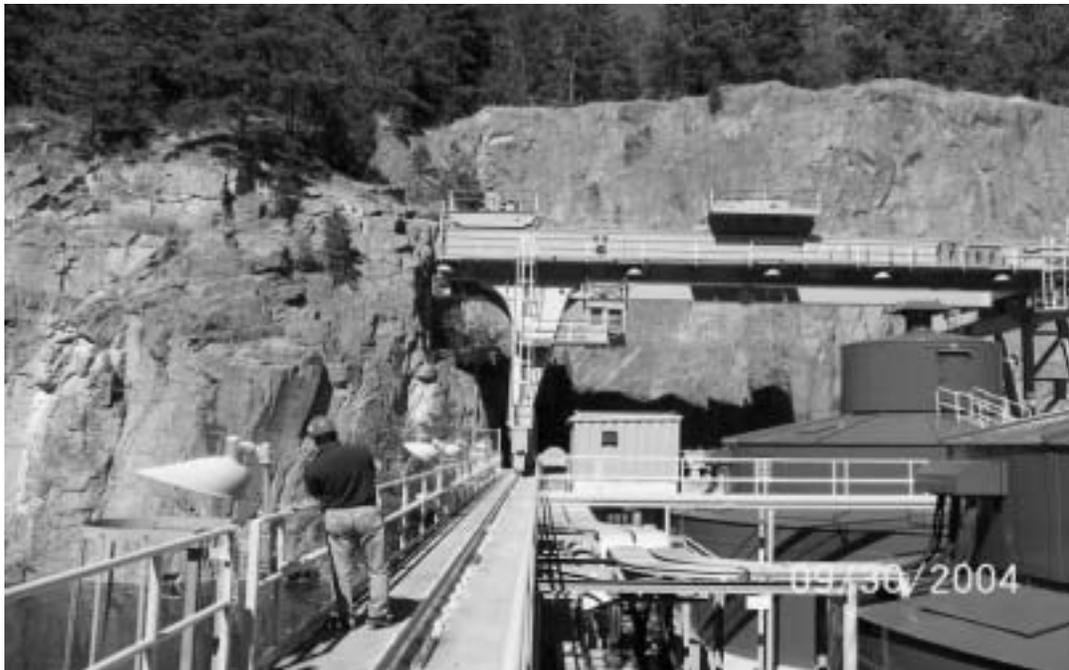
Photograph 22 - Same as the above.

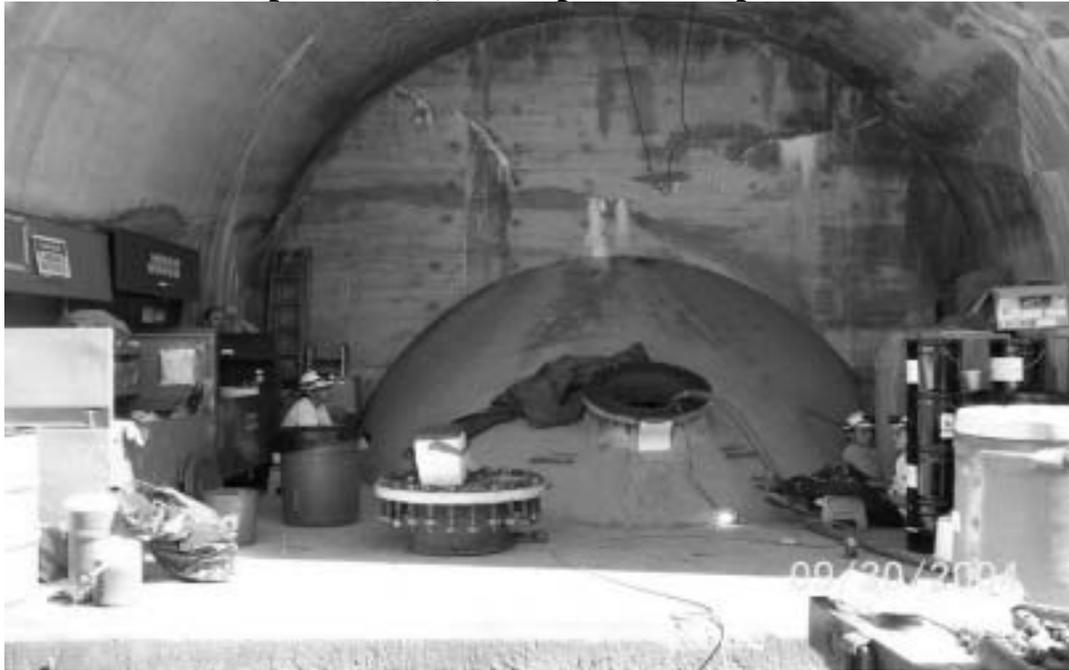
We noted that there was runoff exiting the slope above the penstock portal. Since the quantity of seepage is small, and the licensee is monitoring the seepage, we recommend continued monitoring.

Photograph 23 - The penstock portal area.

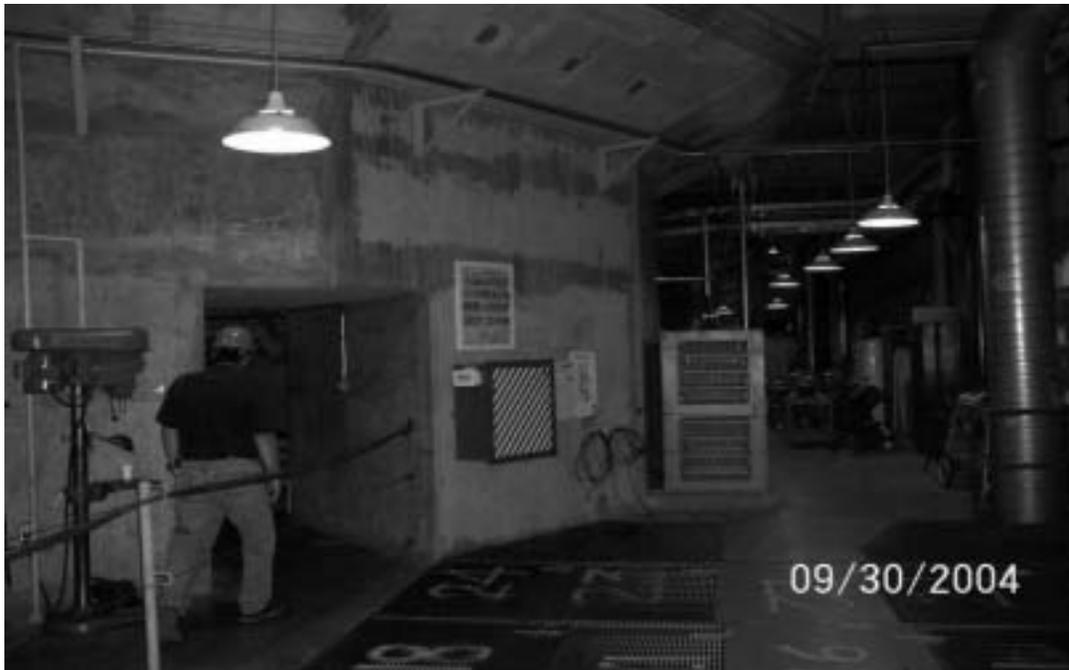
Photograph 24 - The powerhouse interior.

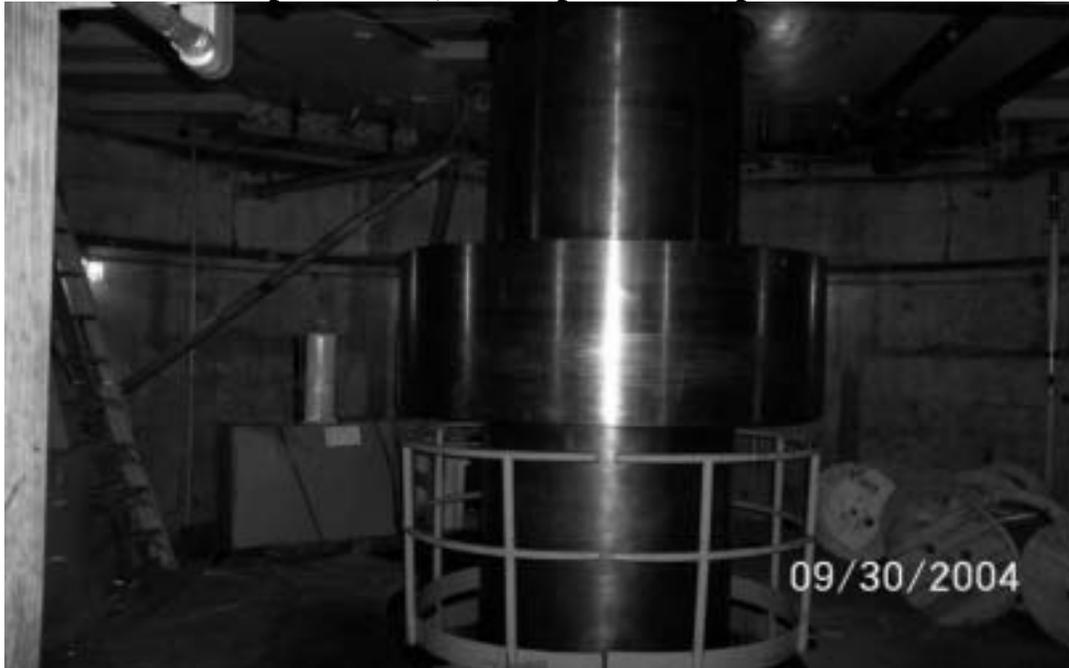
Photograph 25 - Same as the above.

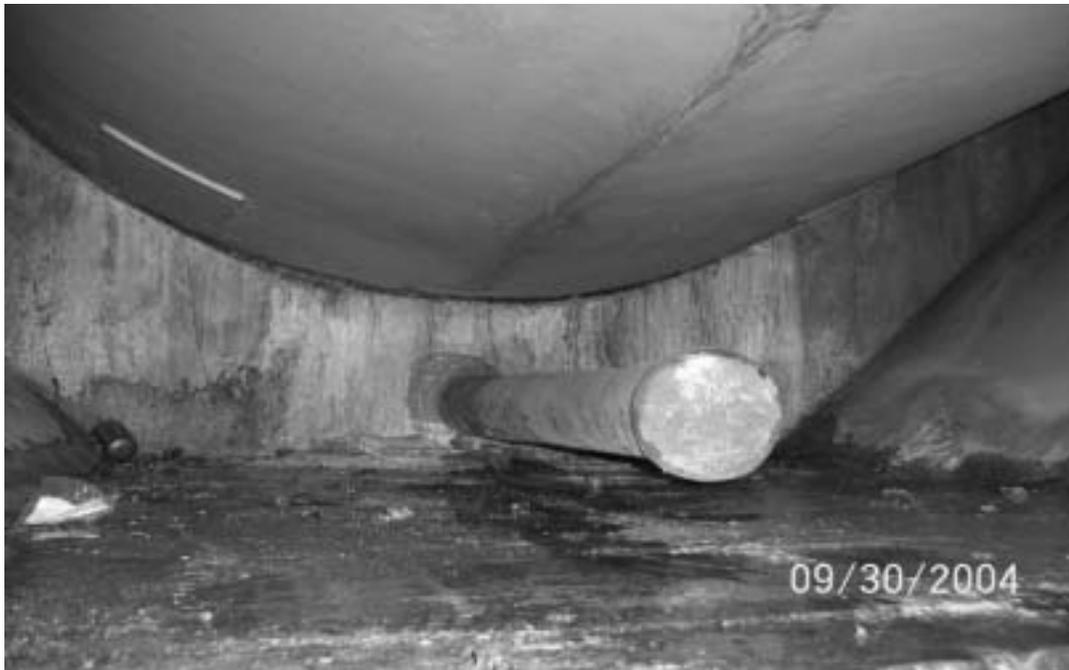
The headwall, where the steel penstocks enter the powerhouse, appeared in good condition with no significant cracking, and with efflorescence and very minor leakage from the joint around the opening (Photograph 26).

Photograph 26 - The area around the penstock and head wall.

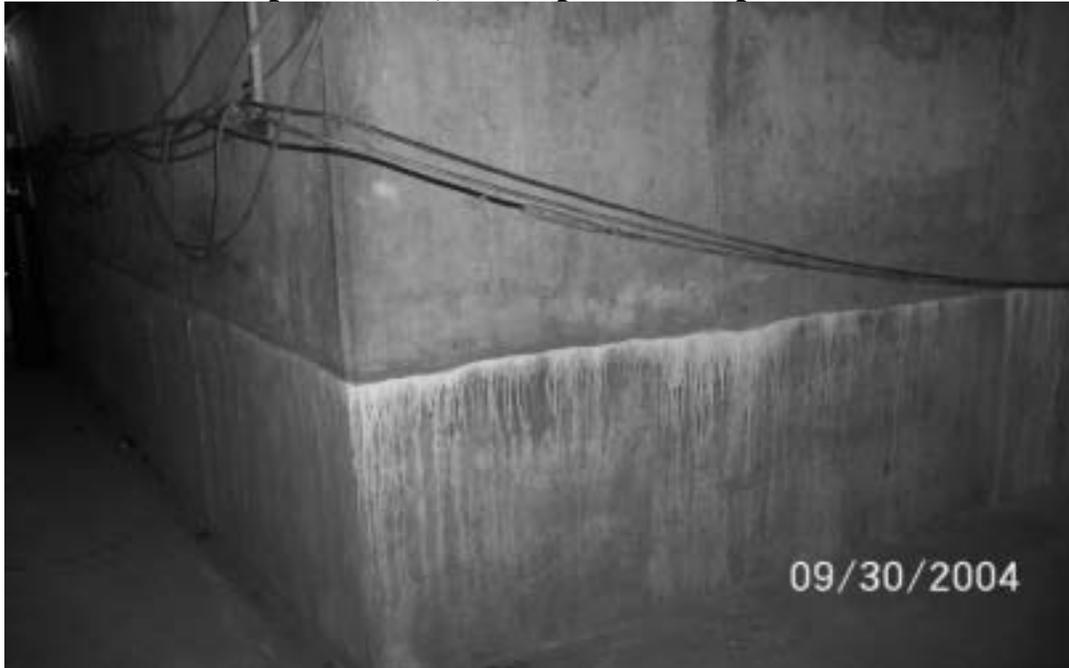
Photograph 27 - Crack around unit housing.

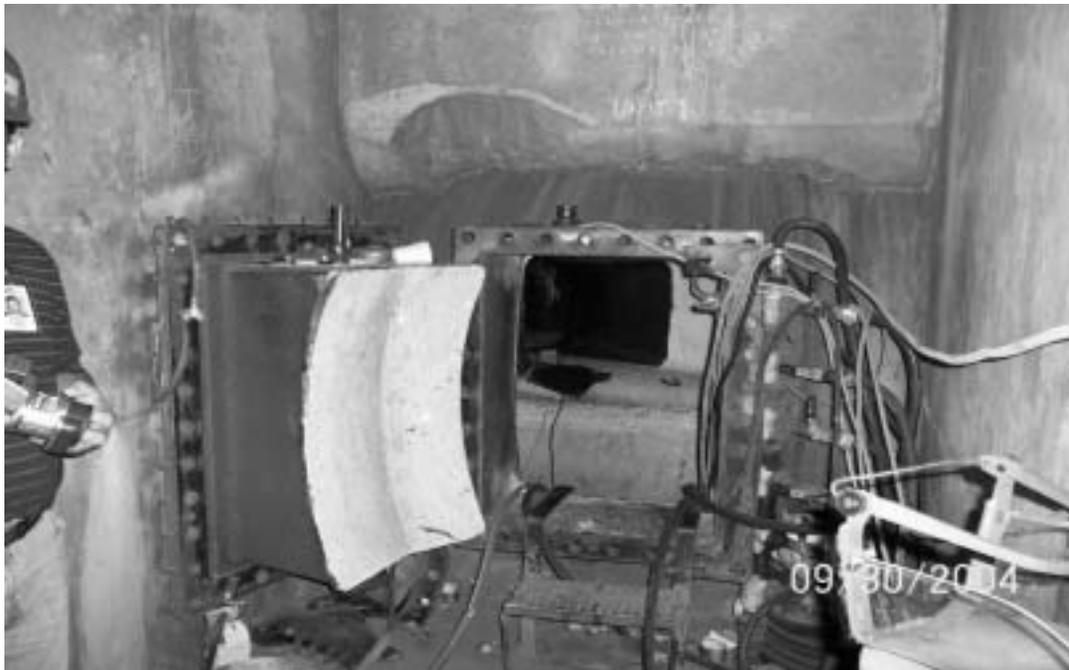
Photograph 28 - The scroll case manhole cover of Unit 1.

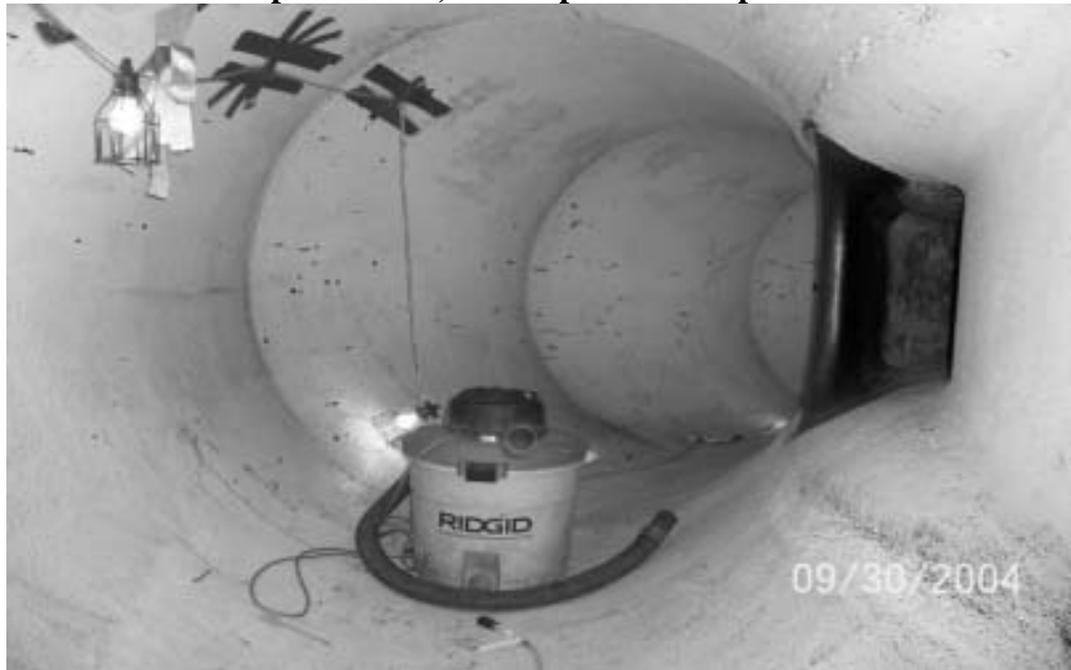
Photograph 29 - The scroll case of Unit 1.
