OPERATION REPORT
FEDERAL ENERGY REGULATORY COMMISSION
OFFICE OF ENERGY PROJECTS
DIVISION OF DAM SAFETY AND INSPECTIONS
CHICAGO REGIONAL OFFICE

For the period October 23, 2003 to September 30, 2004

Licensee Ameren UE Project No. 2277

Project Name Taum Sauk NATDAM Nos. MO30040 and MO30041

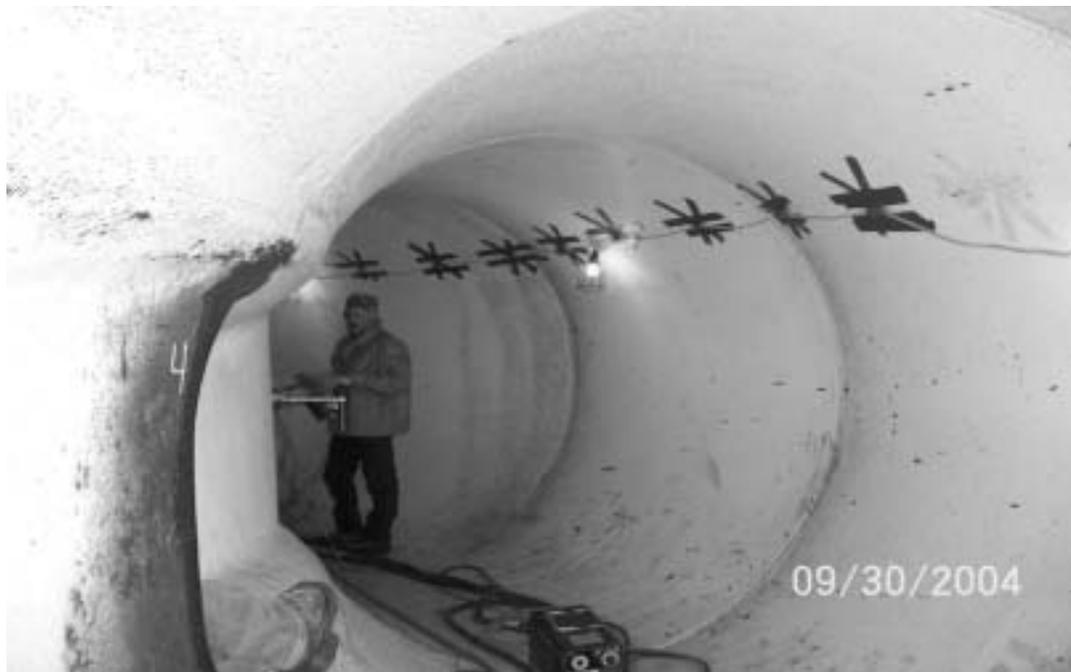
Photograph 30 - Same as the above.

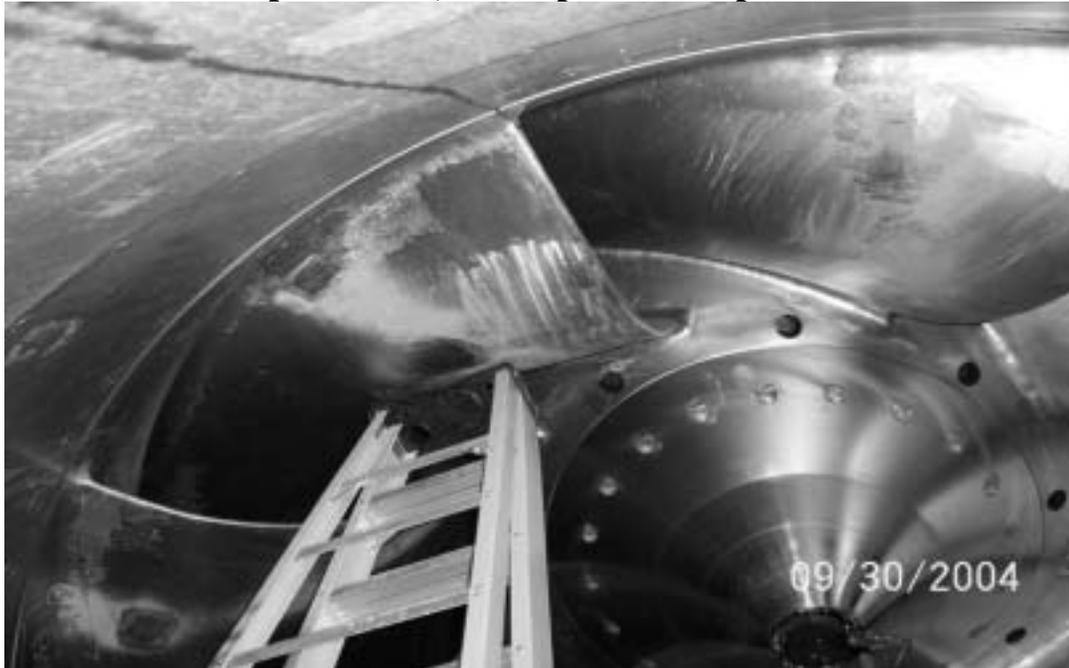
Photograph 31 – Inside bottom view of the runner.

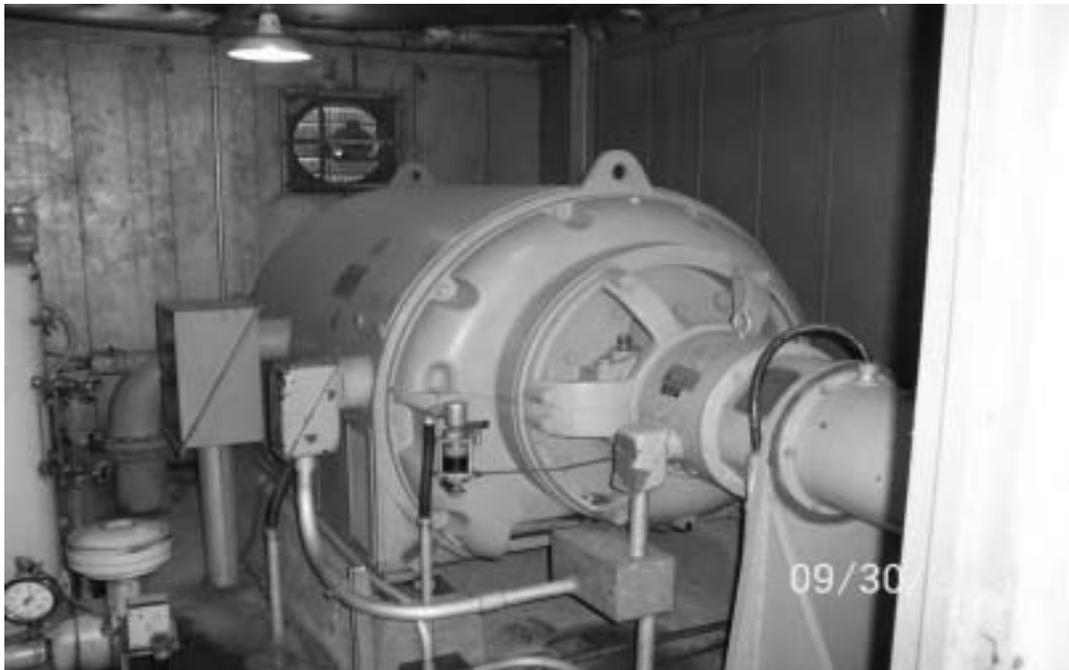
Photograph 32 - The auxiliary unit.
