OPERATION REPORT
FEDERAL ENERGY REGULATORY COMMISSION
OFFICE OF ENERGY PROJECTS
DIVISION OF DAM SAFETY AND INSPECTIONS
CHICAGO REGIONAL OFFICE

Licensee Ameren UE Project No. 2277

Project Name Taum Sauk NATDAM Nos. MO30040 and MO30041

Inspected by Teodor Strat Date August 25, 2005

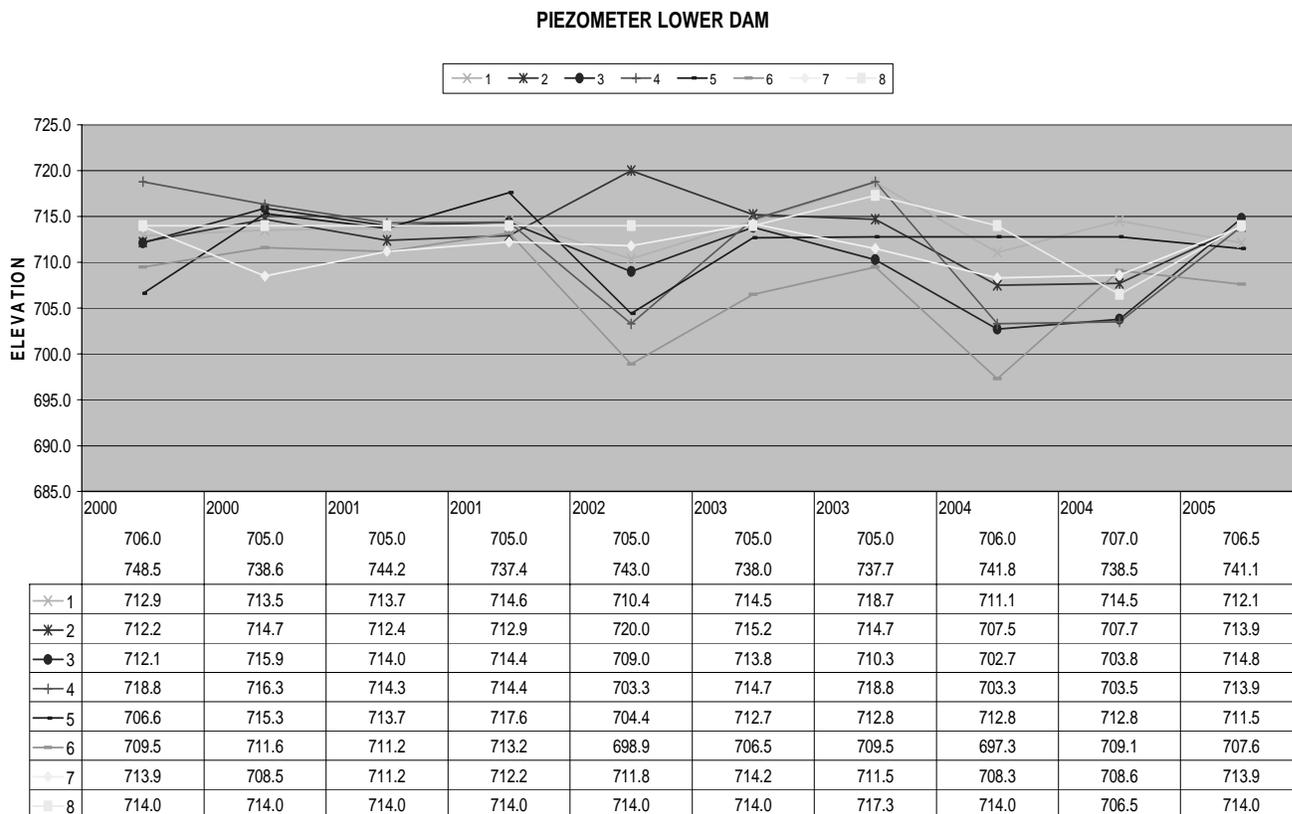
The licensee also maintains eight piezometers in the gallery of the lower dam and monitors them twice a year. During this inspection, we reviewed piezometer readings for the past several years and found uplift pressures to fall within normal ranges (see Figure 1, below).

Figure 1 – Piezometer readings at the lower dam.

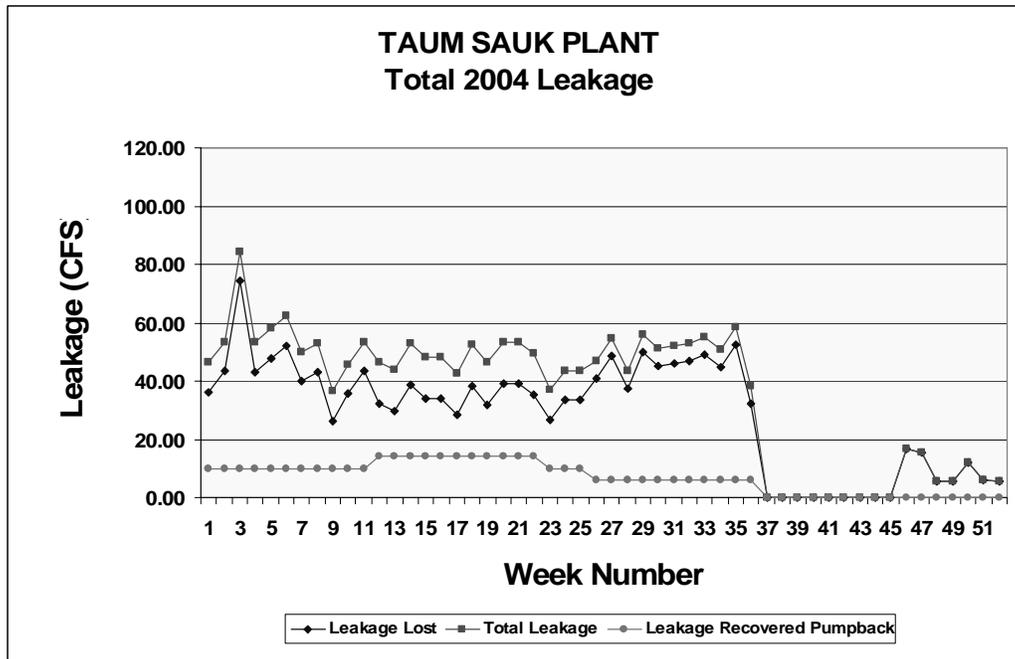
In accordance with Article 34 of the license, the licensee monitors the leakage from the upper reservoir and sends us a report on weekly observations every six months. The latest report was filed July 5, 2005. A dramatic decrease in the amount of leakage from the upper reservoir, when compared with the same period in 2004, was noted. This clearly indicates that the placement of the geomembrane last year significantly lowered the leakage losses through the embankment (see figures 2 and 3, below).

Figure 2 - Total leakage 2004.

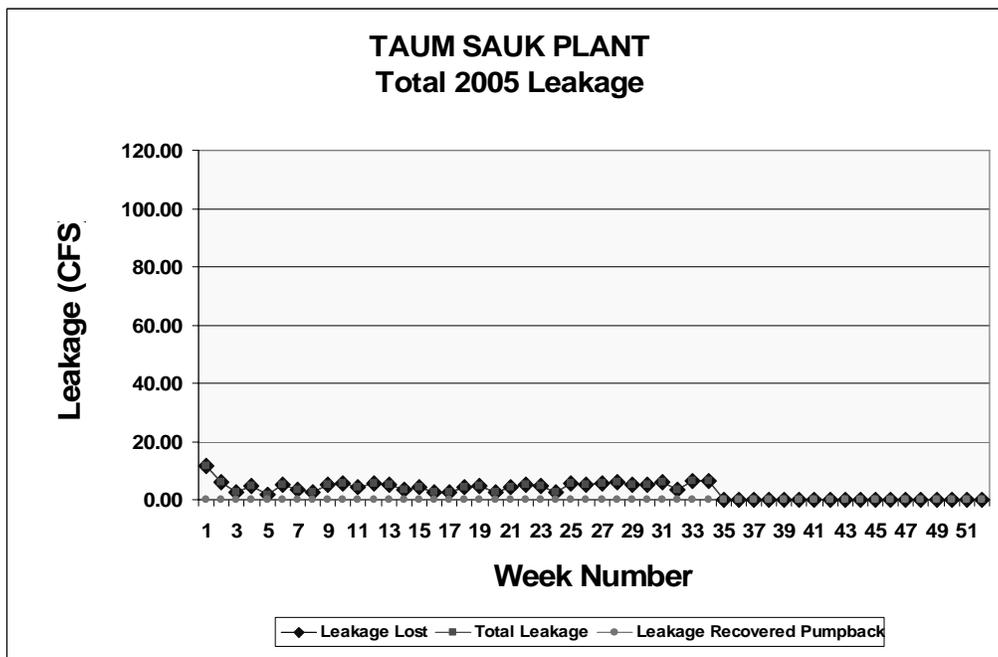
Figure 3 - Total leakage 2005.

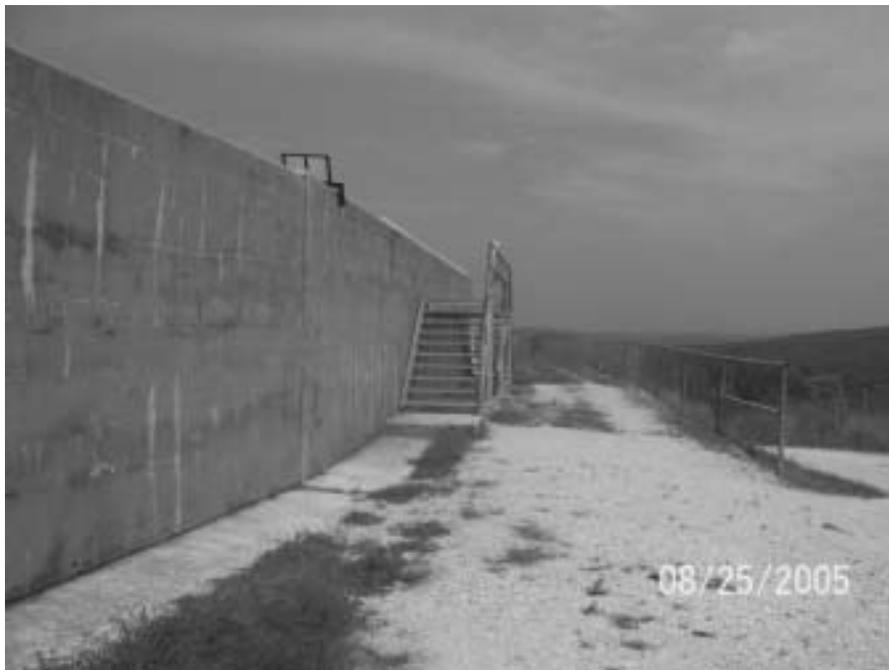
Photograph 6 - The 10-foot parapet wall that crowns the embankment.

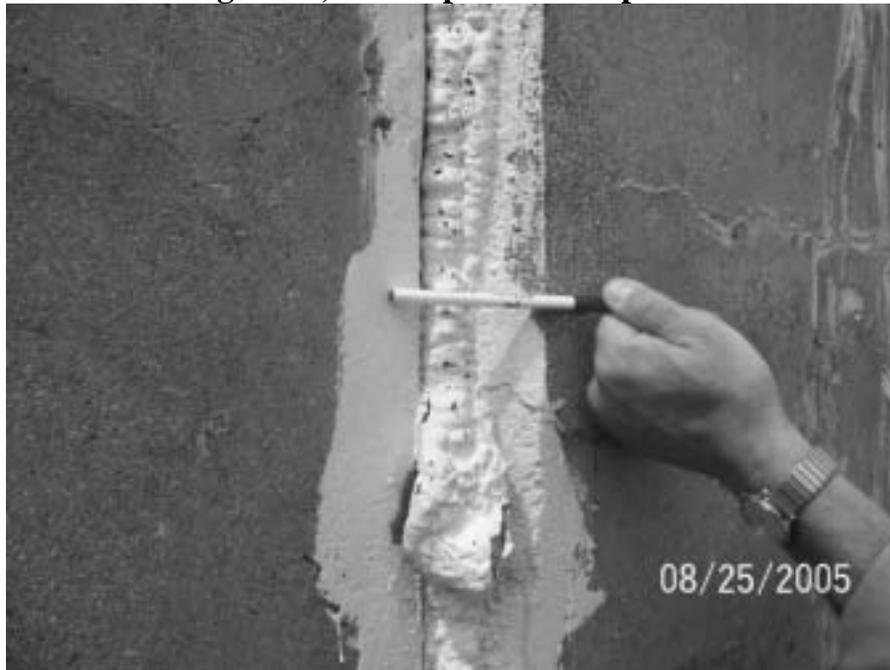
Photograph 9 - Sealed cracks in the parapet wall.

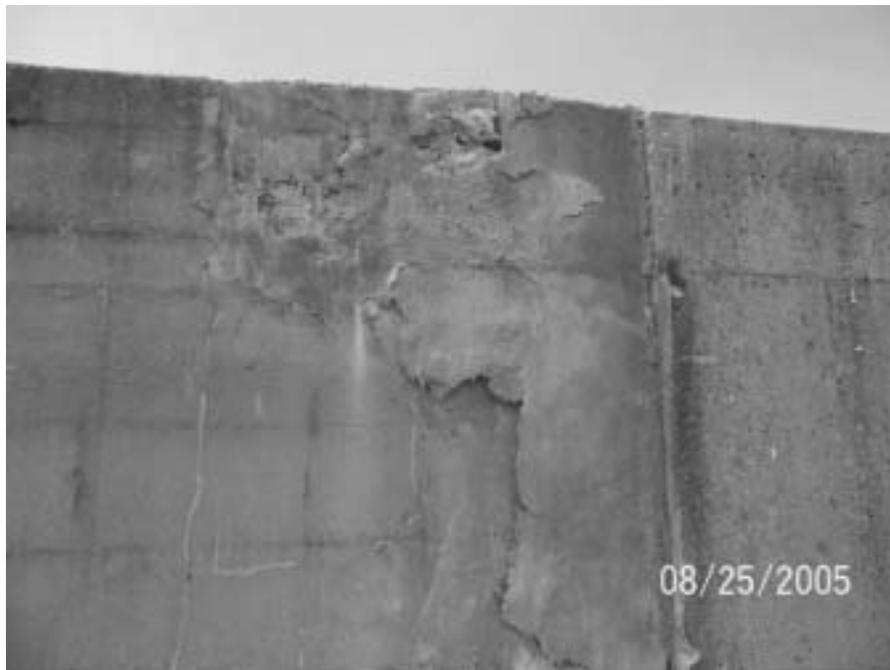
Photograph 10 - Repairs of deteriorated concrete made over the years.

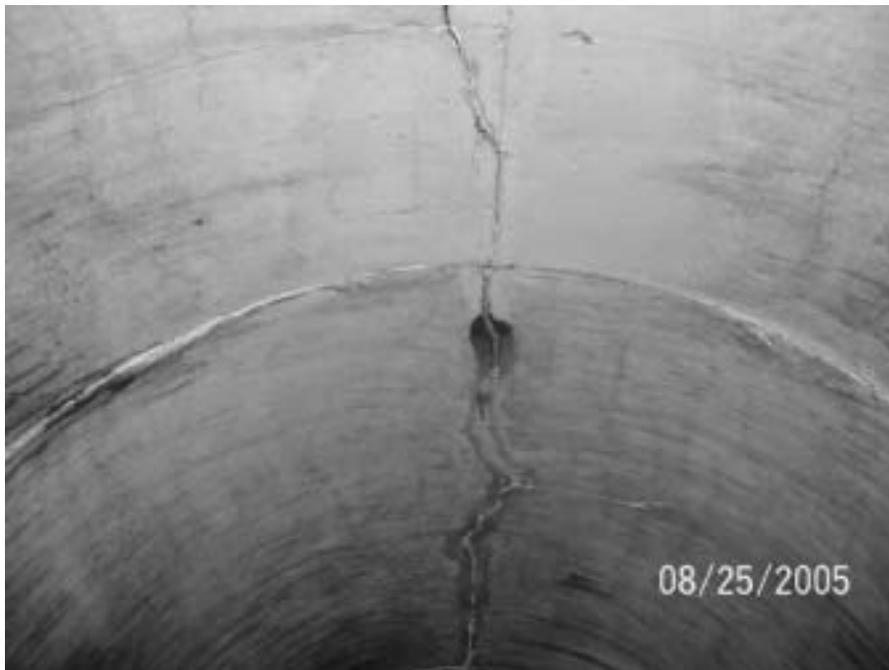
A concrete lined access tunnel is located on the northeast side of the Upper Dam, which allows access to the floor of the reservoir when it is dewatered. The access tunnel was inspected and found to be in good condition (Photographs 12 and 13). Except for the crack in the crown of the tunnel, no significant cracks or leakage were noted in the lining.

Photograph 12 - Crack along the apex of the concrete lined access tunnel.

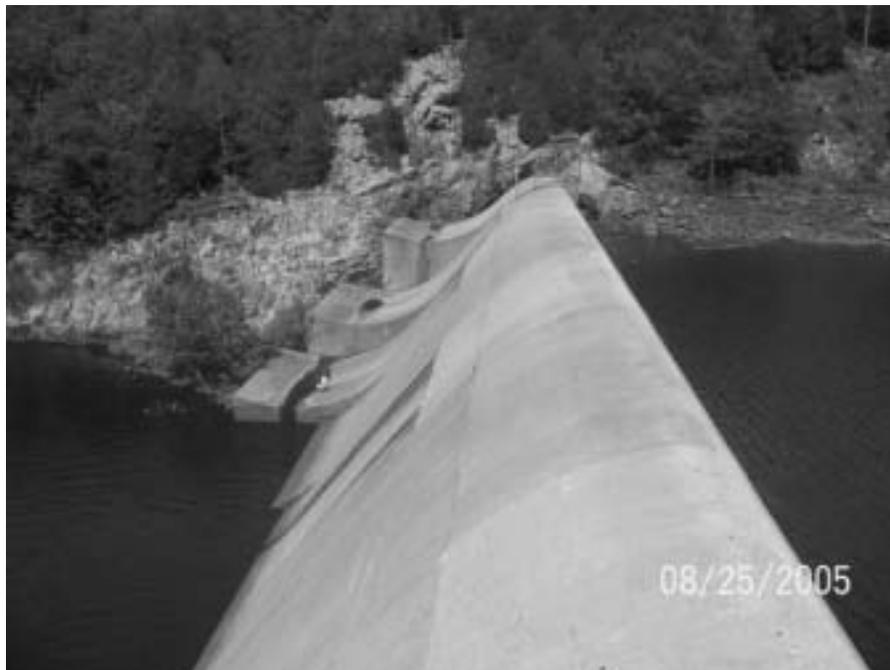
Concrete Dam- The lower reservoir gravity dam is about 60 feet high and 390 feet long founded on rock with rock abutments at each end (Photographs 18 - 21). Both abutments were in good condition at the time of our inspection with no signs of instability or excessive seepage. The concrete appeared to be in good condition with no evidence of significant cracking, spalling, deterioration, or displacements. Minor leakage was noted along horizontal joints in the monoliths but the discharge was very small (Photographs 18 and 19).

Photograph 18 - The crest of the lower dam.

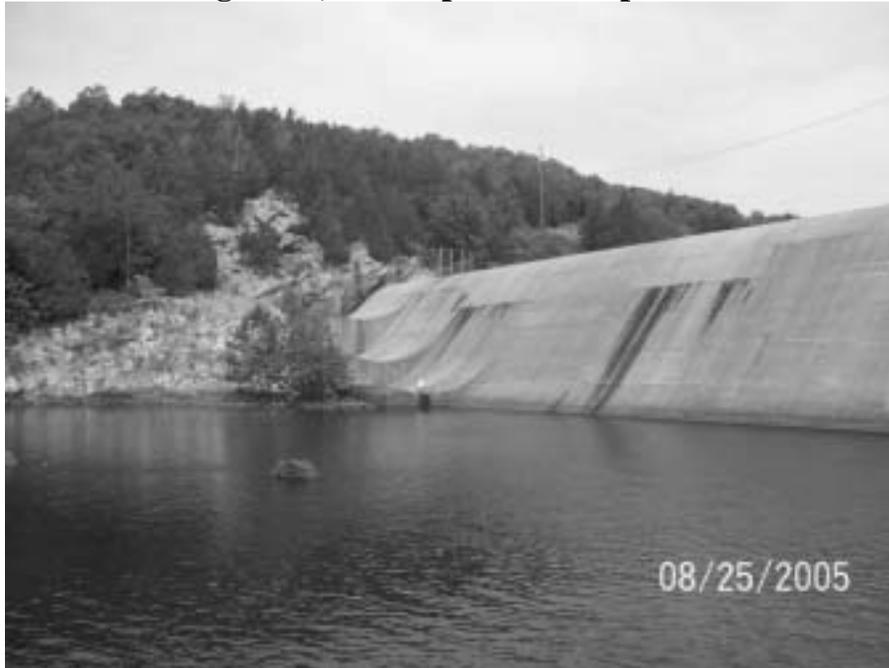
The minimum flow valve was open about 5% at the time of our inspection. No other flow was occurring over the dam. The plunge pool below the toe of the dam appeared to be in good condition (Photograph 19).

Photograph 19 - The downstream face of the lower dam.

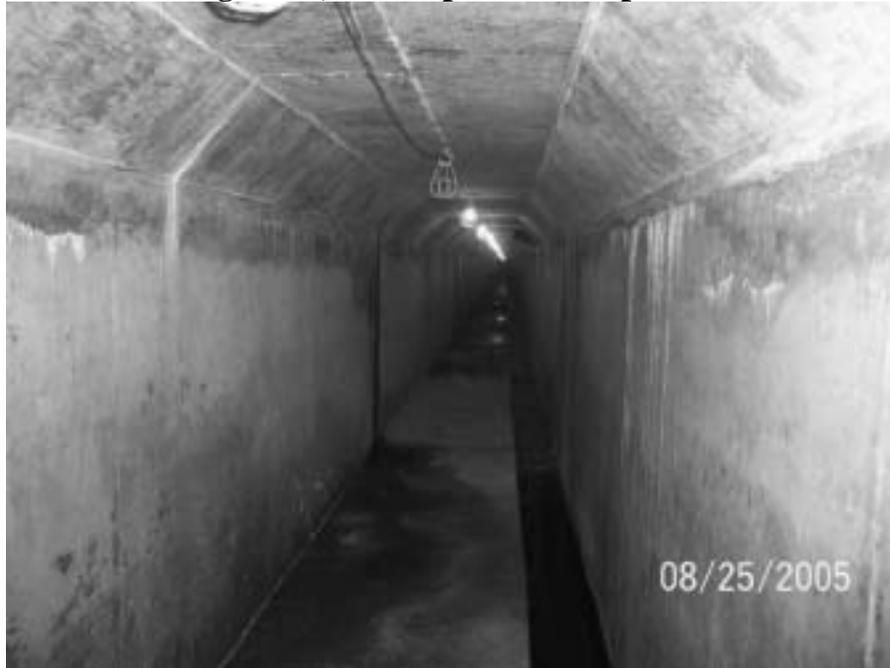
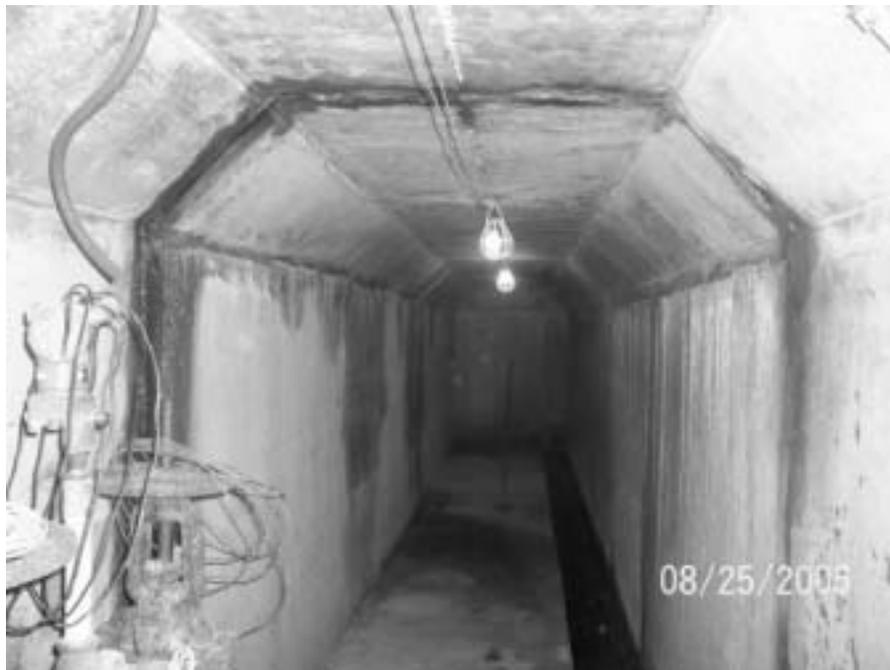
The inspection gallery had not changed since our previous inspections and appeared stable and relatively dry (Photographs 25 through 27). Only isolated seepage, cracks and efflorescence were noted in the gallery. The gutter was free of debris and draining freely.

Photograph 25 - Inspection gallery in the lower dam.

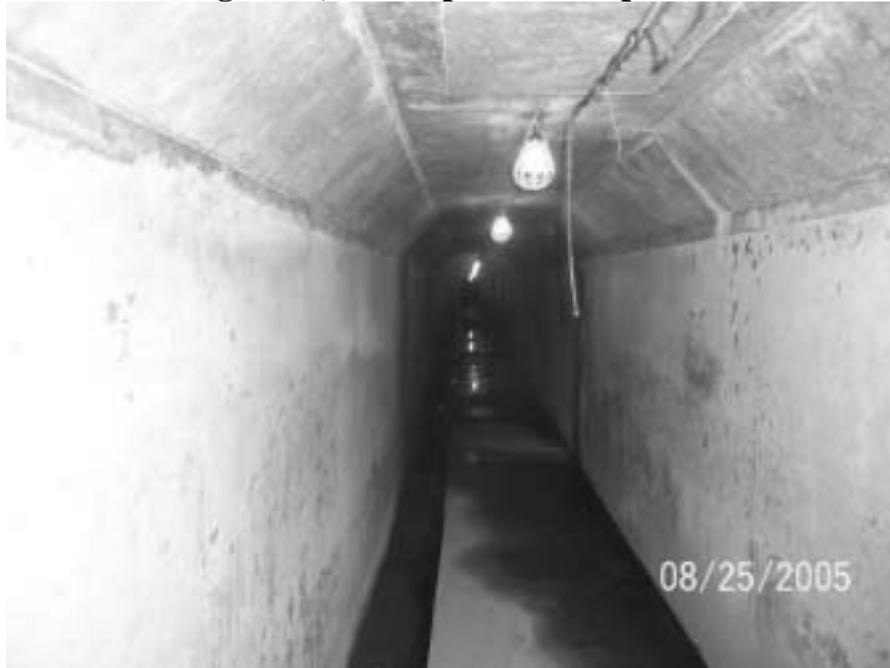
Photograph 27 - The concrete appears in very good condition.

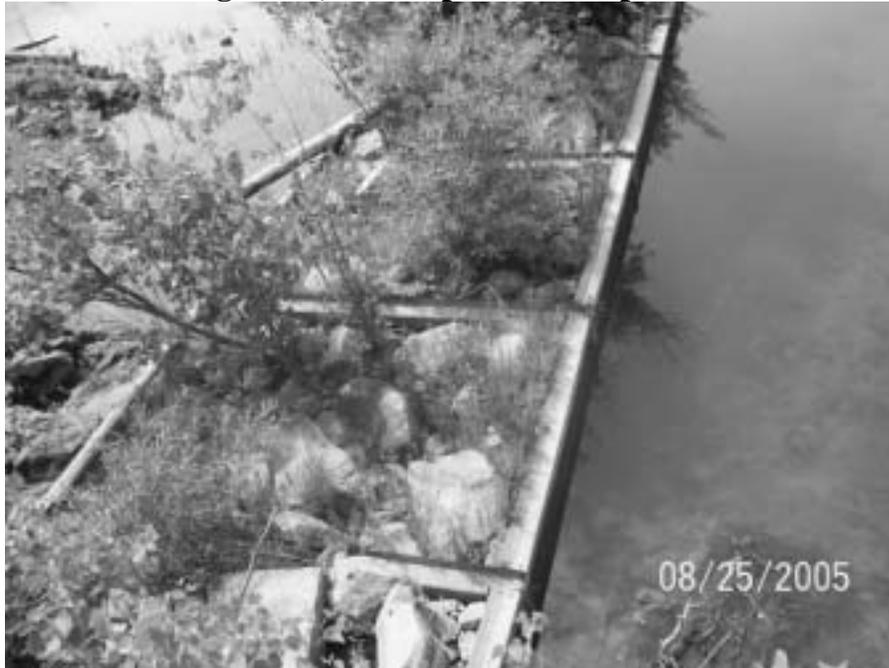
Gravel Trap Dam: The gravel trap dam is a low head low hazard steel sheet-pile and rock crib structure designed to trap gravel in the river before it washes into the lower reservoir (Photographs 28 and 29). At the time of our inspection the dam was in good condition. No separation of interlocks or leakage of fill was observed; however, significant vegetation was observed at the crest of the dam. The licensee will be asked in the follow-up letter to control the vegetation growth on this structure.

1. Excessive vegetation was noted on the crest of the gravel trap dam. The licensee was asked to include vegetation control on this structure in their regular annual maintenance program of the project.

Photograph 29 - Same as the above – note excessive vegetation.

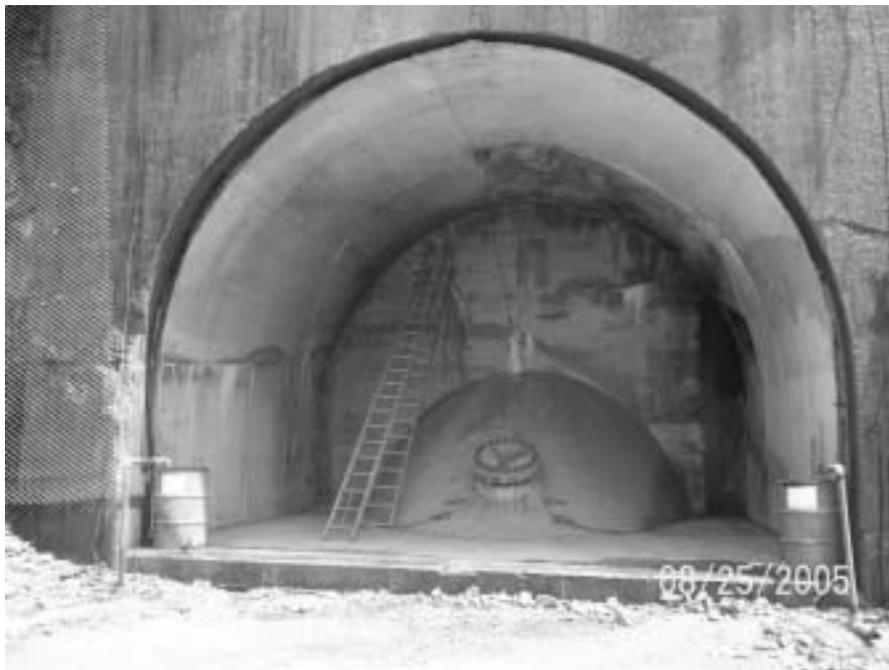
The area surrounding the powerhouse is shown in photographs 30 through 34. We noted that there was runoff exiting the slope above the penstock portal. Since the quantity of

Photograph 34 - The penstock portal area.

seepage is small, and the licensee is monitoring the seepage, we recommend continued monitoring.

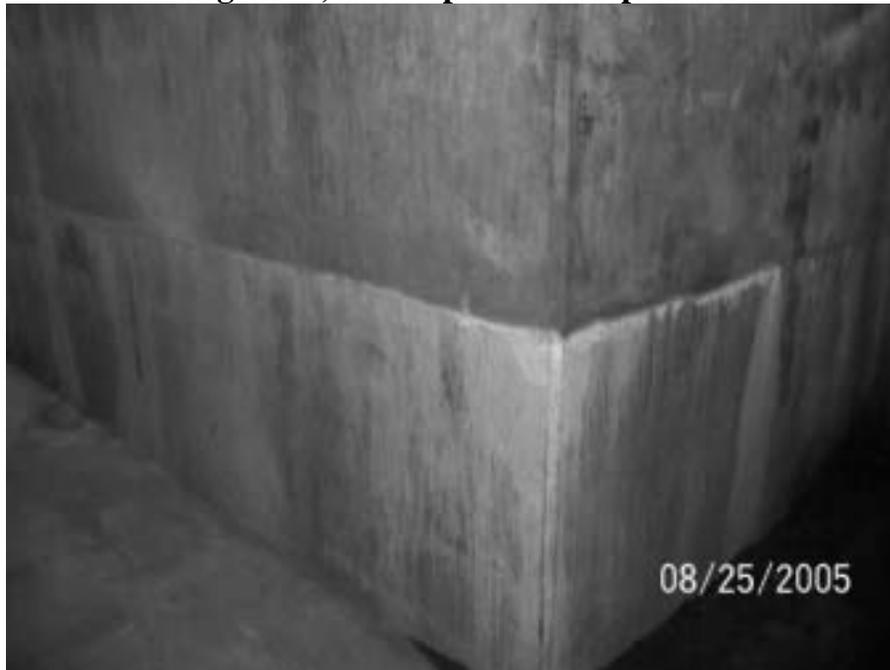
Photograph 37 – Crack around unit housing.

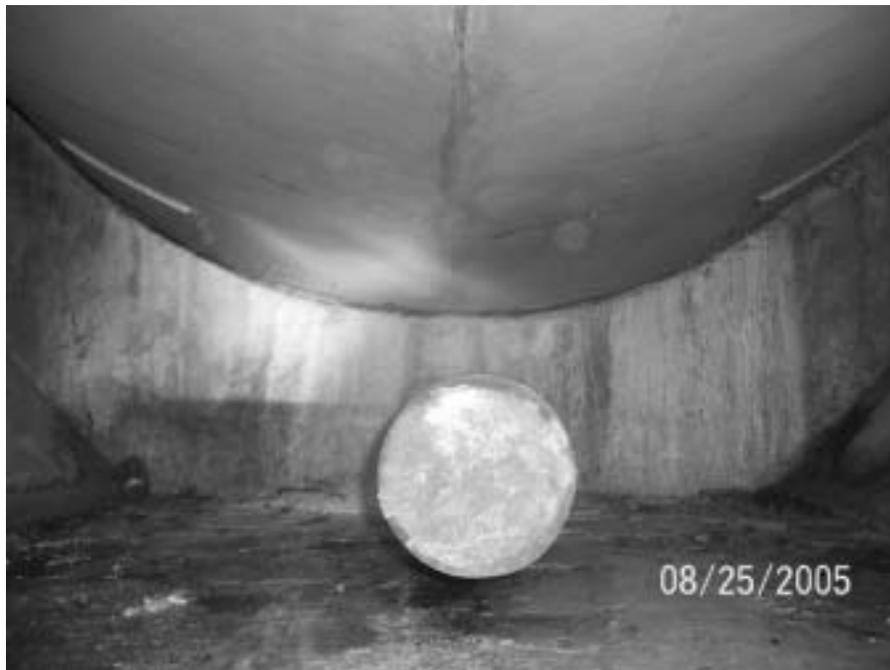
The headwall, where the steel penstocks enter the powerhouse, appeared in good condition with no significant cracking, and with efflorescence and very minor leakage from the joint around the opening.

Photograph 38 – The area around the penstock and head wall.
